PAWEŁ KONCZEWSKI, JERZY PIEKALSKI

## THE STREETS OF MEDIEVAL WROCŁAW – METHODS OF CONSTRUCTION AND FUNCTIONS

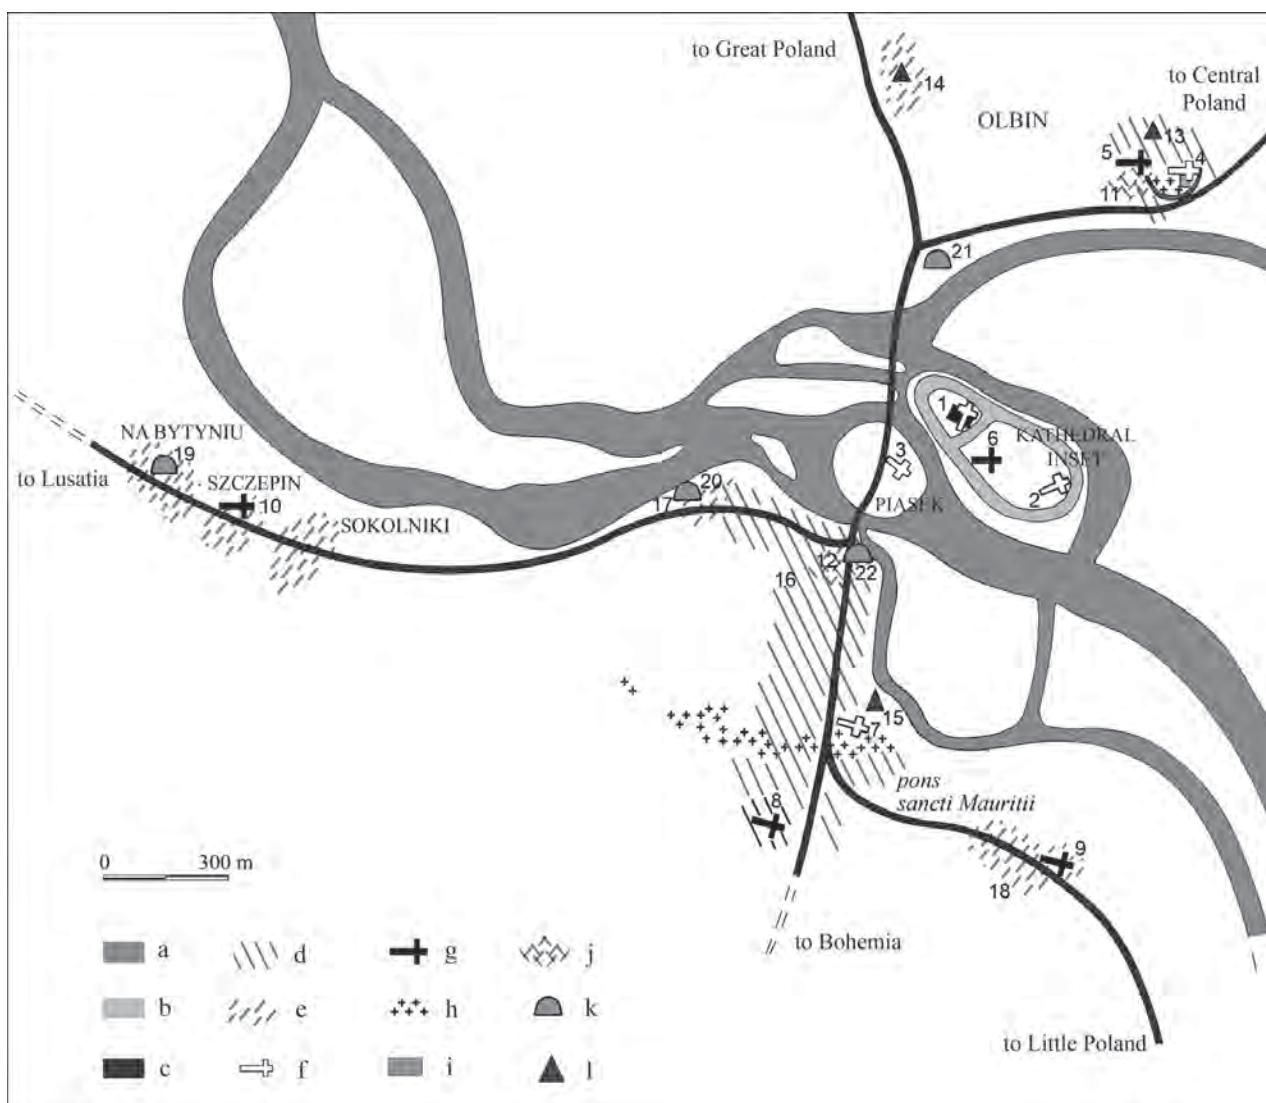
Fig. 1. Wrocław, settlement districts predating the rise of the communal town (after M. Mlynarska-Kaletynowa with supplementary data from J. Piekalski and P. Konczewski): 1 – stronghold with its chapel; 2 – St John Cathedra; 3 – Augustinian Abbey with the church of Our Lady; 4 – Premonstratensian abbey with St Yincet church; 5 – St Michael church; 6 – St Peter church; 7 – St Wojciech/Adalbert church; 8 – St Mary of Egypt church; 9 – St Maurice church; 10 – St Nicholas church; 11 – site of the annual market in front of St Yincet church; 12 – presumable location of the market in the district on the left bank; 13 – estate of the noble Włostowic family; 14 – estate of the nobleman Mikora; 15 – presumed location of the estate of Gerung; 16 – district centred on St Adalbert church; 17 -Jewish district; 18 – Walloon district; 19 – inn in the district “Na Bytyniu”; 20 – inn “Birvechnik”; 21 – inn “ad fine pontis”; 22 – inn of the Augustinian Abbey. a – flows, b – rampart of the stronghold, c – main roads, d – settled zone (based on archaeological research), e – settled zone (based on written sources), f – located churches, g – churches with an approximate location, h – graveyards, i – secular and monastic brick/stone buildings, j – markets (based on written sources ), k – inns (based on written sources ), l – mansions (based on written sources ).

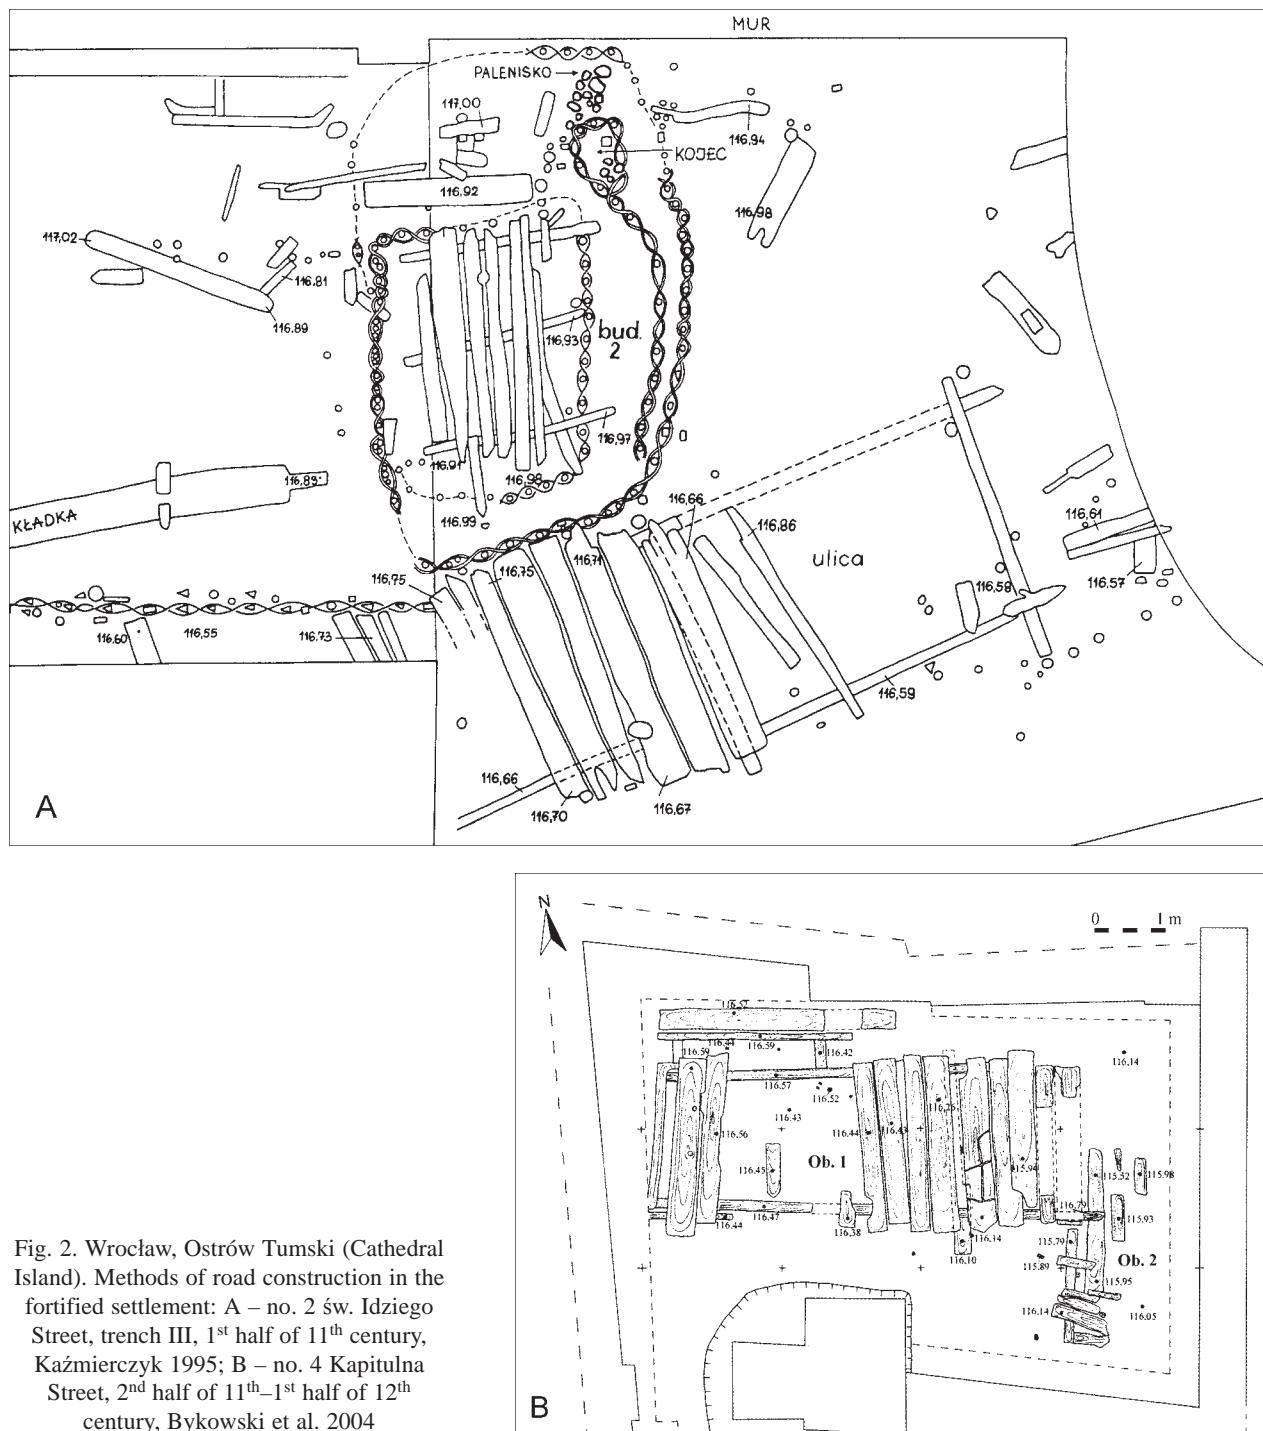
with bundles of brushwood or with timber recycled from repaired ramparts (fig. 2ab, Bykowski et al. 2004, p. 120, 148). The left bank of the Odra mostly had dirt roads although some of the more waterlogged stretches may have had raised wooden walkways for pedestrian traffic. It was so in Szewska Street, on the corner with Nankera Square (fig. 3).

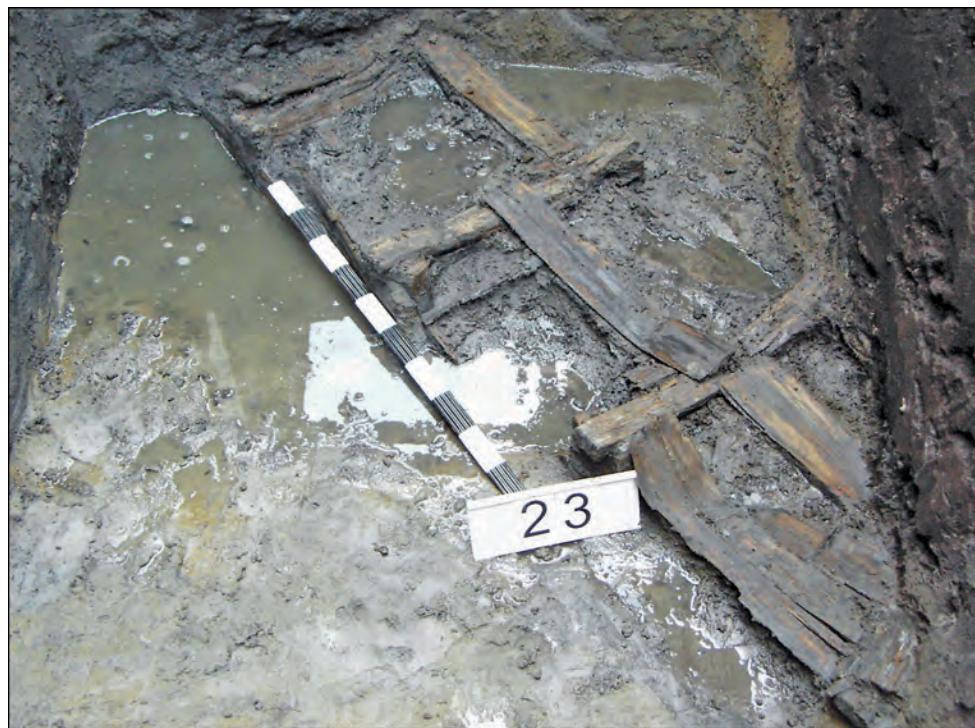
Fig. 3. Wrocław, Szewska Street/Nankera Square. Timber-lined surface of a pedestrian walkway. Photo. P. Konczewski

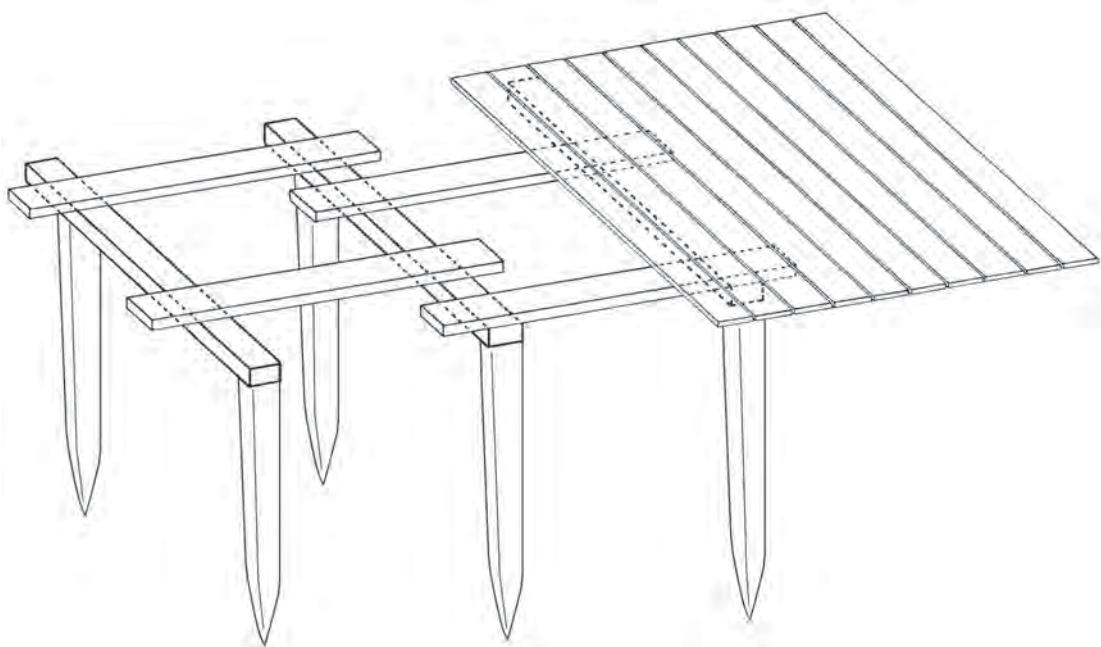
Fig. 4. Wrocław. Graphic reconstruction of a street walkway. Drawing N. Lenkow

More stable timber road surfaces were introduced during the 13th century only rarely, as their more widespread use characteristic for the 14th century. Technically the most advanced streets were surfaced in the form of raised walkways (fig. 4). Construc-

tion started with vertical timbers being driven into the soggy ground. Over them, at right angles to the line of the street, supporting timbers were laid every 3–4 m. Next came a layer of sleepers laid parallel to the line of the street. Only over this substructure the road surface was laid – transverse 46 cm thick rough planks (Kaźmierczyk 1966–1970, part 2, p. 63–64, fig. 14; Mruczek 2000, p. 263–271). This method of construction is documented in the main streets of the better off districts in Wrocław (Pańska, Junkierska, Oławska, Kurzy Targ, Kotlarska streets), and in the northern areas, on lower lying ground, also in streets inhabited by less well off tradespeople (Szewska, Łaciarska, Malarska, Drewianka). Rough planks covered a 2–2.5 m wide area down the middle of the street; Kaźmierczyk (1966–1970, part 2, p. 62) suggested that even up to the width of 4.5 m. In the market squares raised walkways were provided only for passage through the square. It is notable that the presence of these walkways, especially in the northern districts of the town, was remembered in typical Wrocław street names – Schmiedebruecke, Schuebruecke, Oderbruecke (Stein 1995, p. 20, 66).

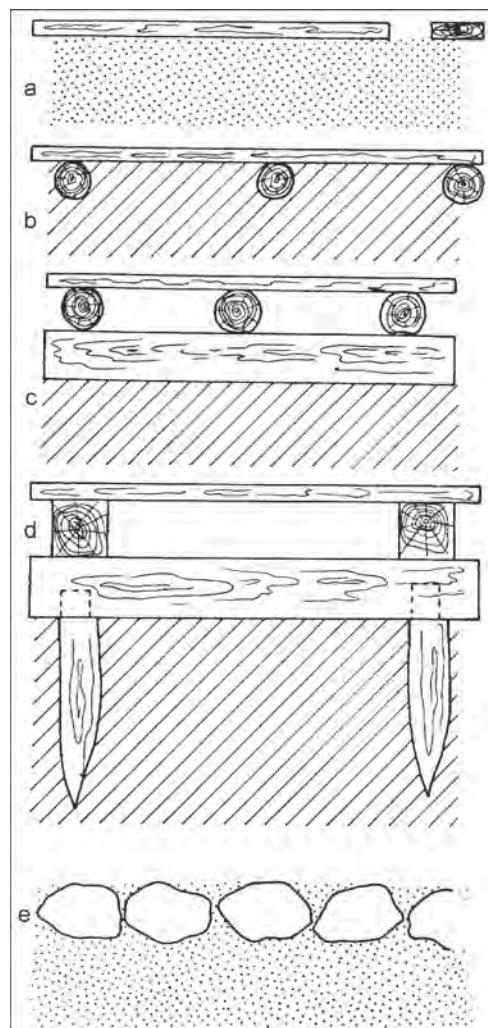
Fig. 5. Wrocław. Street constructions of a medieval town, Kaźmierczyk 1966–1970, part 1, with supplement from the authors

1970, part 2, p. 60–63). They were used especially on the street margins next to the town plots, but also to repair or temporarily improve stretches of the main streets. Some elements of the raised walkway were dispensed with (fig. 5). If the ground was not likely to become compressed, no stabilising uprights were used. The structure then consisted of just the supporting timbers laid crosswise over the sleepers surfaced with rough planks laid at right angles to them. The next step towards simplification was to leave out the supporting timbers. In this case the sleeper beams rested directly over the organic layer or over a bed of sand. These simplified techniques of street surface maintenance are reflected in the culture deposit as a sequence of layers of humus-and-animal-manure alternating with a layer of sand (fig. 6). Spreading the streets with sand was a method used regularly to drain them and keep them clean and level. The ratio of sand to manure could be as high as 7:1. The structure of the stratigraphic sequence shows that the muddy road surface was spread repeatedly with a layer of sand several centimetres thick. With time this sand was probably absorbed by the dirt in the street, unless its top layer was consolidated in some way for example by lining the sandy layer with loosely laid rough planks. Traces of such a treatment have been detected on occasion (Buško 1997; 1999). They have the form of a well-defined top layer of the sandy stratum, with occasionally, at the bottom, smudges from decomposed wood. In stratigraphic sequences they are observed as a sort of a „layer cake” built by alternating layers of sand and humus

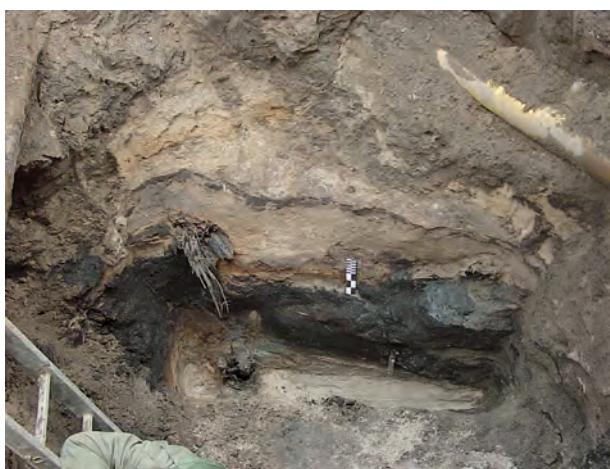
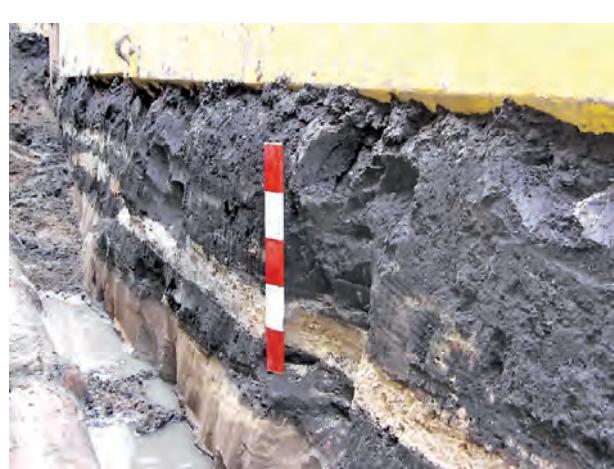
Fig. 6. Wrocław, Kiełbaśnicza Street. Layers of humus and sand. Photo. R. Kamiński

(fig. 6). More rarely, the edge of the street was surfaced with a pavement of pebbles, laid right over the muck or humus, something which has been observed in a number of locations in Szewska Street.

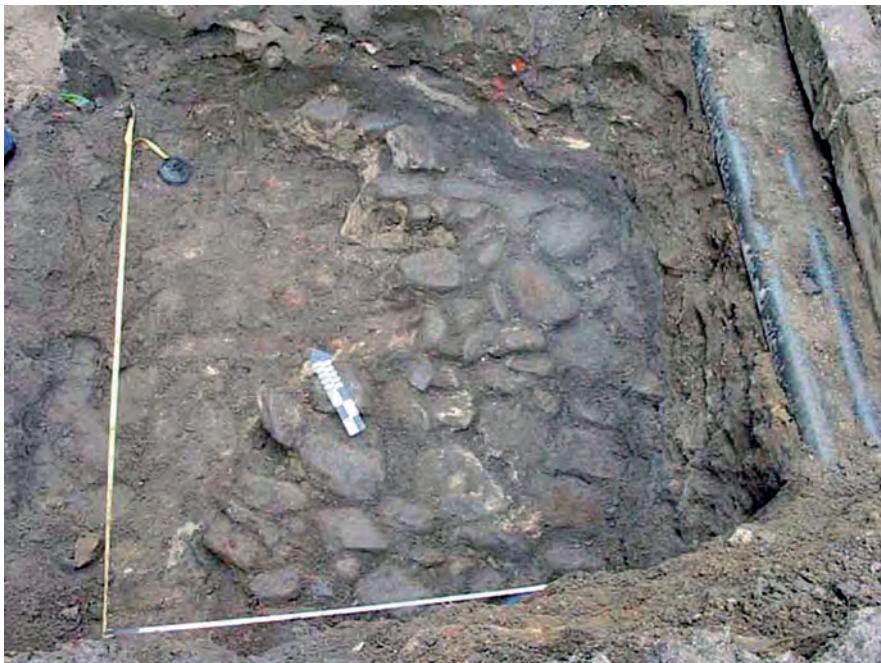
Fig. 7. Wrocław, Kielbaśnicza Street. Stone pavement, 14<sup>th</sup> century. Photo. R. Kamiński

In point of fact, the most advanced method of keeping the layer of sand in the street more or less intact was to cover it with a pavement of stones. In Wrocław pavements were built of post-glacial cobbles which are typical in the European Lowland (fig. 7). The best quality pavements were laid over a bed of pure sand which helped to level and drain the ground below and create a stable substrate for the stonework. This resulted in a rise of the ground level by 20–40 cm, sometimes, even by up to 80 cm. The diameter of the cobbles was on average 15 cm, at most, around 20 cm. They were laid close together in stretches bounded by courses of larger stones or rough planks set vertically (on end). The earliest stone pavements of Wrocław, in its Market Square, have been dated to late 13<sup>th</sup> century (Buśko 1997, p. 118; Płonka, Wiśniewski 2002, p. 121n; Bresch et al. 2002, p. 14n). Their distribution there was localised. They lined the passages across the market and some of the access ways to some market stalls.

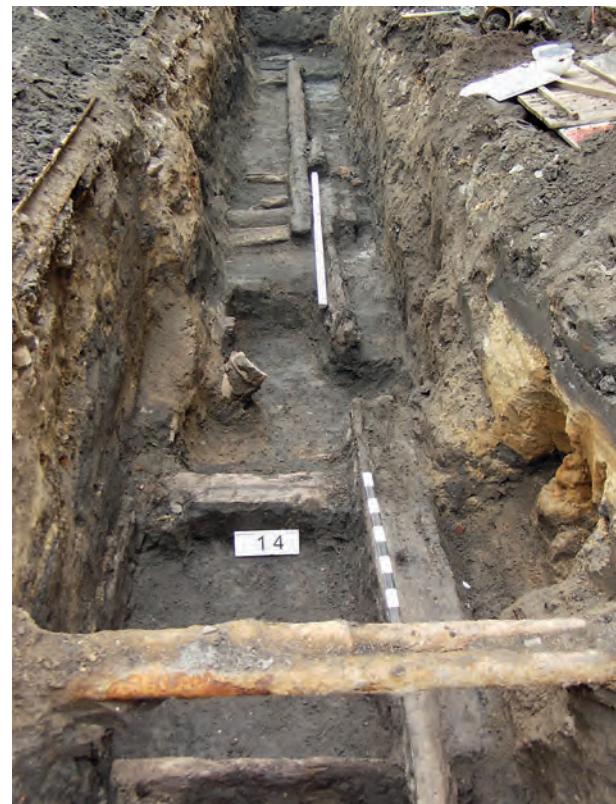
Fig. 8. Wrocław, Szewska Street. Partly dismantled road surface. Photo. P. Konczewski

a thick layer or muck. When these timber structures had served their purpose they were partly dismantled in order to recover the better fragments of oak-beams and rough planks (fig. 8). This practice throws light on the ways the timber resource was managed. Road surfaces were built of raw material recycled after several score years in service in other structures, mostly buildings, bought at a lower price. And even the soggy wood battered from long years in use in the street was still considered worth recovering.
