I. THE ARCHAEOLOGICAL INVESTIGATION IN GLIWICE – AN INTRODUCTION

THE MARKET SQUARE AND THE TOWN HALL – ARCHITECTURAL AND ARCHAEOLOGICAL STUDIES

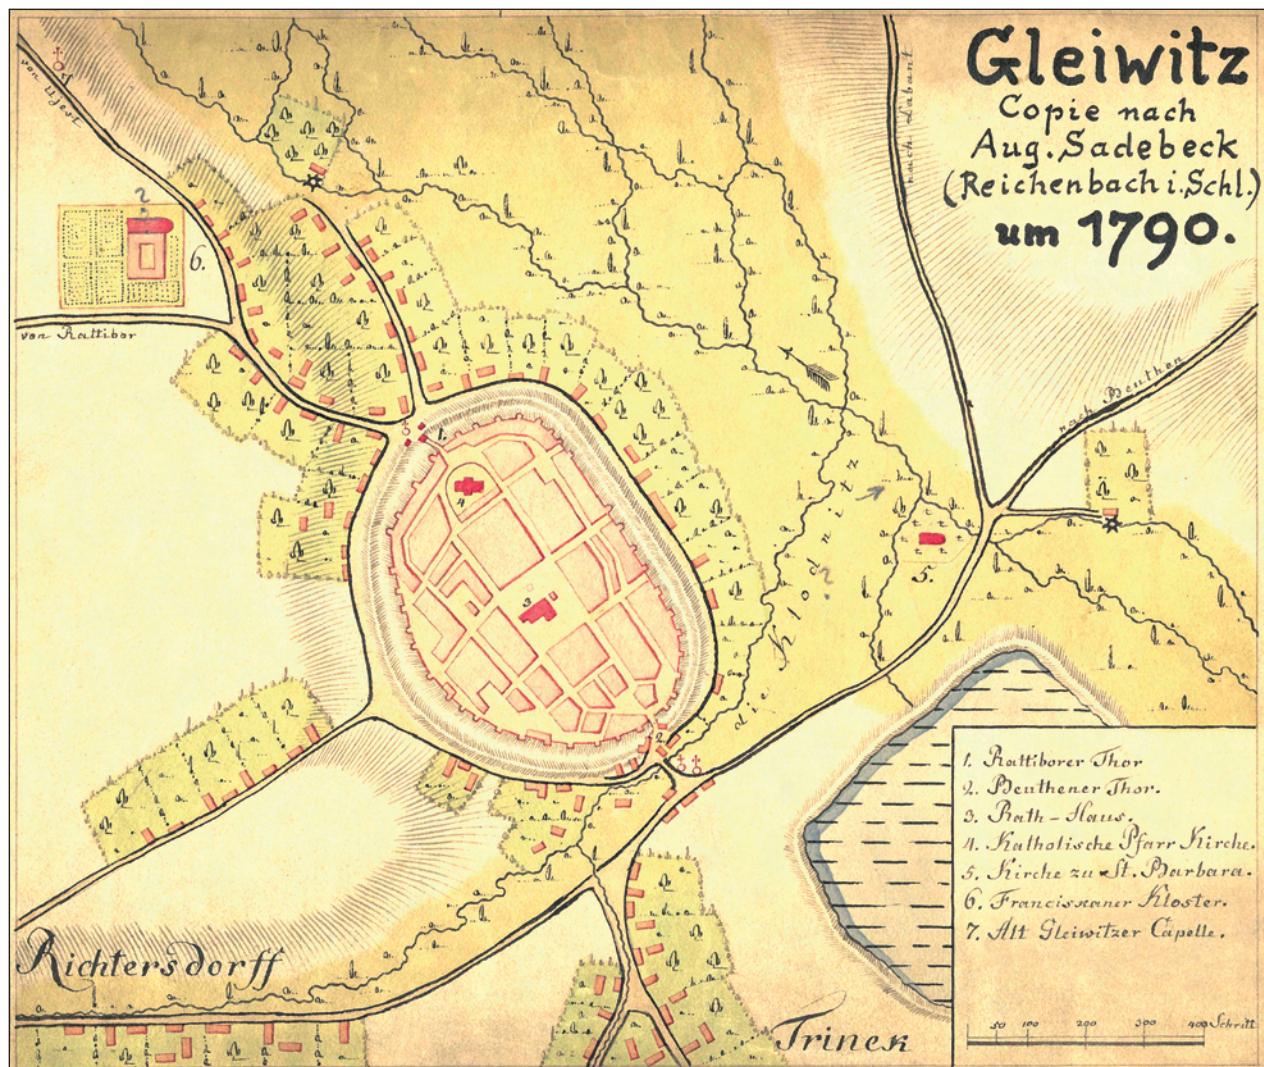
Fig. 3. Gliwice. Town plan from the 18th century, title page of *Krieges Carte von Schlesien*, Ch. F. Wrede

ha making it a medium-sized urban centre in Upper Silesia (Fig. 3).

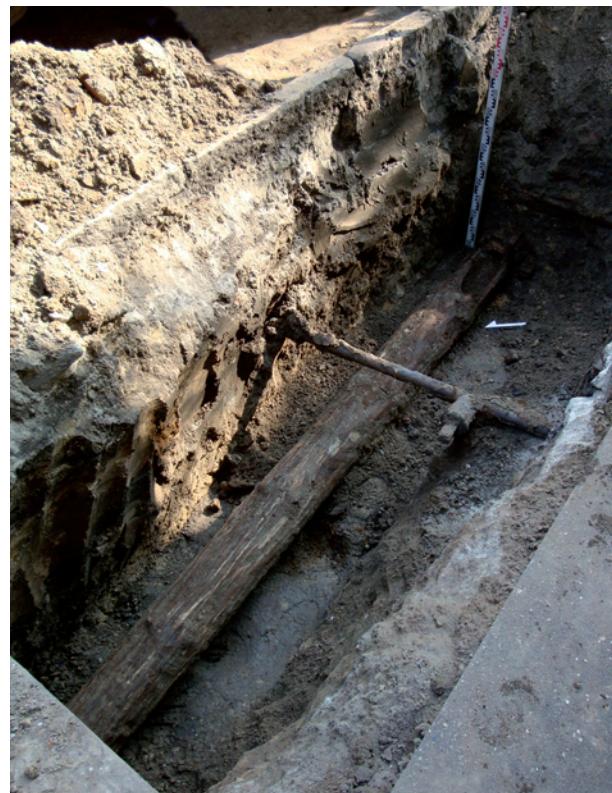
Fig. 4. Gliwice, Dolnych Wałów St. A wooden water pipe.
Photograph R. Zdaniewicz

From 1531, the town had its own water supply system, with wooden pipes carrying water from Wójtowa Wieś, and six gutters draining off the sewage to the Kłodnica River. A fragment of a 4.5 m long wooden conduit, retaining an iron-coupling piece was discovered by accident in 2009 in Dolnych Wałów Street, with a diameter of 0.3 m (and the diameter of the pipe opening was 0.1 m). It has been interpreted as an element of the early modern municipal water supply system (Fig. 4).

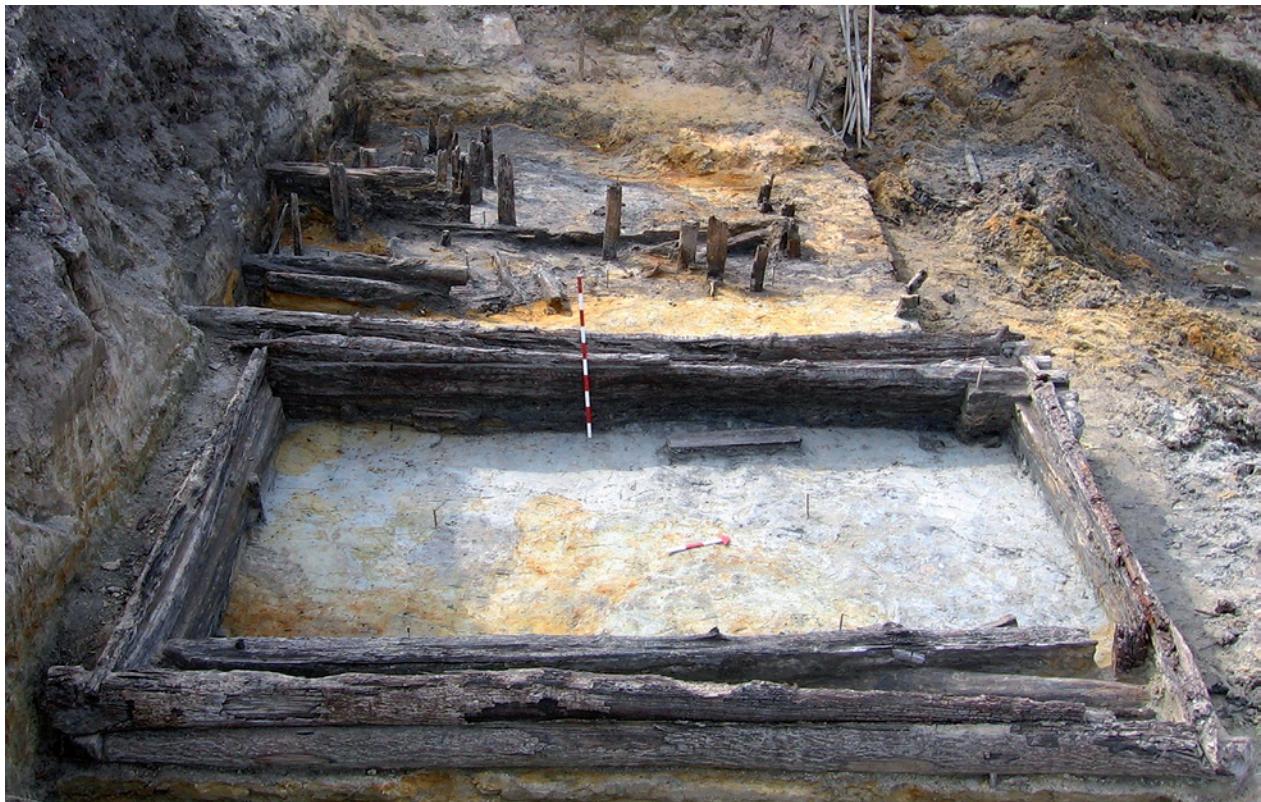
Fig. 5. Gliwice, Jana Pawła St. The remains of a timber building (dwelling), second half of the 16th century.
Photograph M. Michnik

Insight into the functioning of the extramural areas of Gliwice and the appearance of their development at the turn of the Middle Ages and the modern age comes from an archaeological investigation held in 2005 in the street-block between Jana Pawła II and Mikołowska streets, in the former suburb of Bytom. One of the features identified during this study were the foundations of a log-house: a rectangular building 4.7–5 m × 3.4 m in size, built of round logs with their bark intact, these were notched and jointed at the corners (Fig. 5). The height of the surviving structure was less than 0.6 m. The western wall (facing in the direction of the village of Ostropa) survived as two rows of timbers. In all the corners, vertical elements had been added for greater stability of the building's foundations. The walls of the hut were chinked with moss and clay. Its floor of packed grey-coloured clay rested over an insulation layer of branches, again with their bark intact. On its east side, at the centre of the hut, were the remains of a plank, interpreted tentatively as the remains of a wall bench. Small finds from inside the house included a series of pottery fragments, with some complete vessels (e.g. jars, basins, plates and tripods) and tile fragments. There were also some metal and wooden objects, as well as some animal bones. The dendrochronological

analysis identified the timber of the building as pine and oak, and secured two dates – 1551 and 1570. The purpose of this building is hard to establish. The pottery and the tiles it contained suggest it was both a dwelling and a workshop – perhaps, a fulling mill. Next to the hut, a rubbish pit and another log-house were identified, presumably non-residential (Fig. 6). The latter, only partly preserved, was sub-rectangular in plan, 2.25 × 2.7 m. Its north wall survived in the form of three planks, its east and west walls were preserved as two heavily damaged planks. At a distance of 0.9 m from the north wall were the remains of a partition. The walls were insulated with straw. Underneath the plank floor was a layer of decayed branches. The purpose of this building is hard to specify. Given the absence of small finds, its small size and layout it may have been an outbuilding. The remains of sharpened stakes, discovered at a distance of 1.2 m from this building, may be interpreted as a sort of enclosing structure (a fence?). Dendrochronology dates obtained for this smaller building, which was constructed entirely of oak wood, suggest it was built in 1538–1539 (Michnik 2010). Presumably, both log houses went out of use when the city was besieged during the Thirty Years' War.

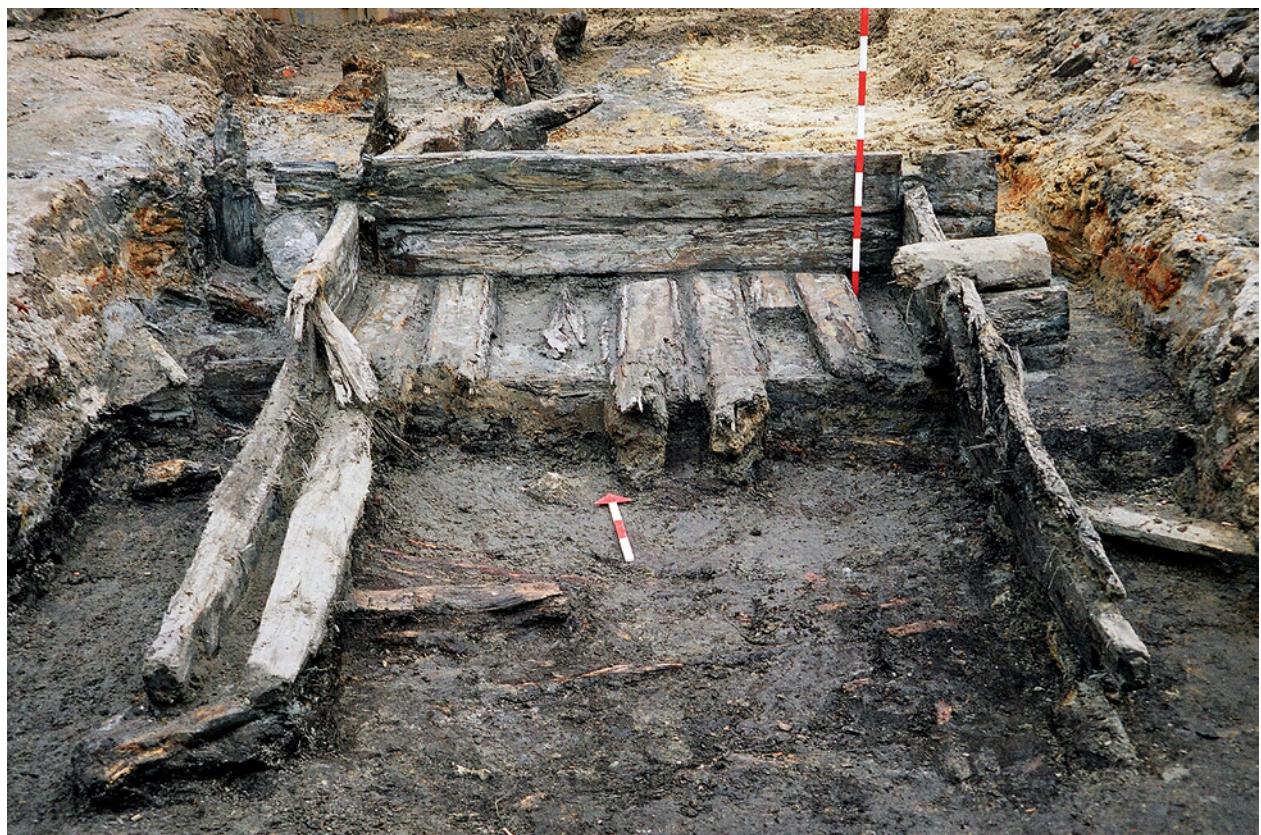
Fig. 6. Gliwice, Jana Pawła St. The remains of a timber building (outhouse), first half of the 16th century. Photograph M. Michnik

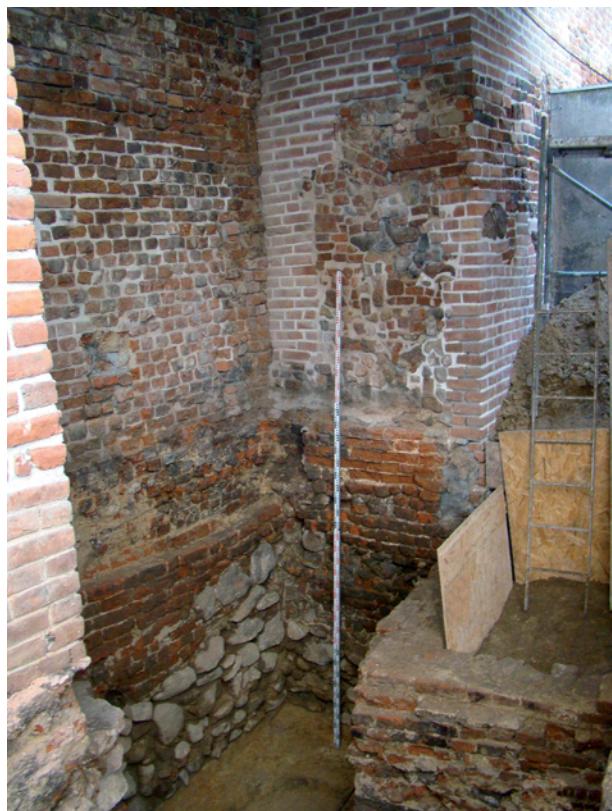
Fig. 8. Gliwice, Basztowa St. Bottom section of the town wall tower, late 15th–early 16th century. Photograph R. Zdaniewicz

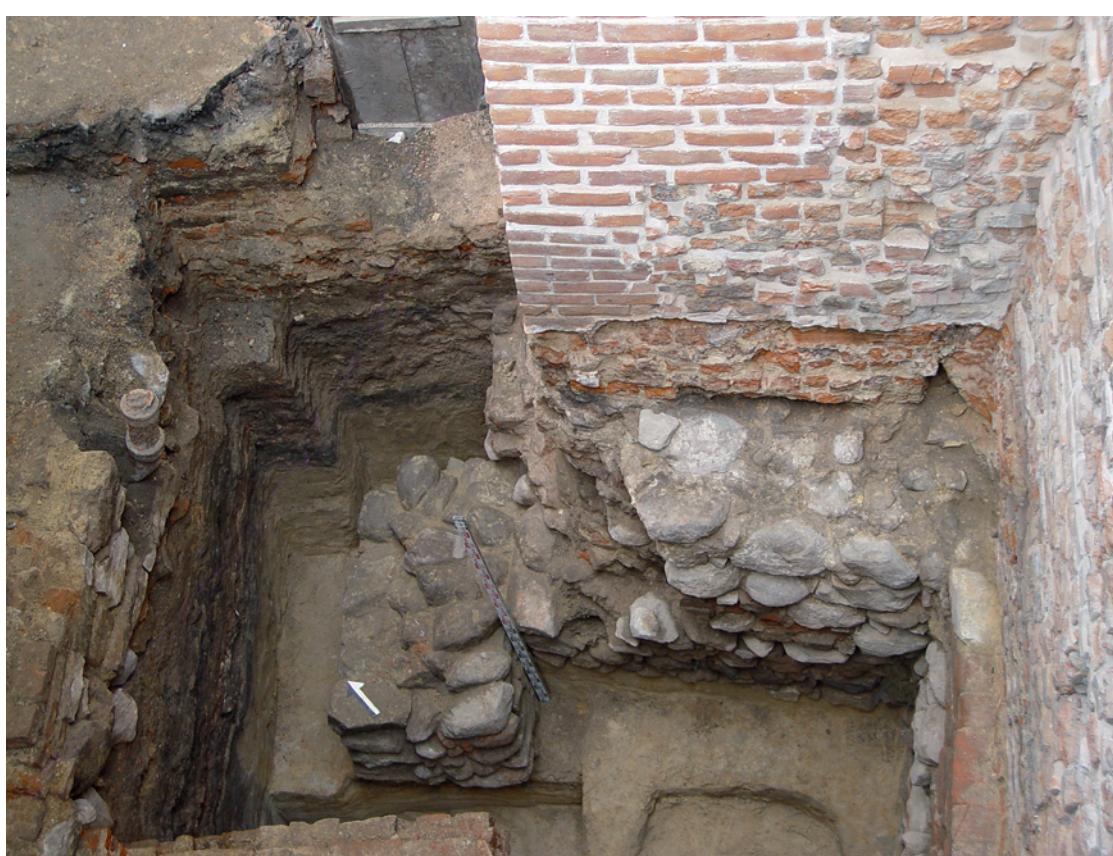
Fig. 9. Gliwice, Basztowa St. Remains of a stone structure, which originally supported a wooden staircase, on the inner face of the town wall tower, the late 15th to the early 16th century. Photograph R. Zdaniewicz

uncovered in 2008 in the half-tower on Basztowa St., was placed at right angles to the wall face and could be the remains of a corbel supporting a wooden stairway which led to the walkway (Fig. 9) (Michnik, Zdaniewicz 2009). A narrow alley ran along the foot of the wall. In a later period, as the wall weakened, it was reinforced with buttresses, both on its outer and inner sides.

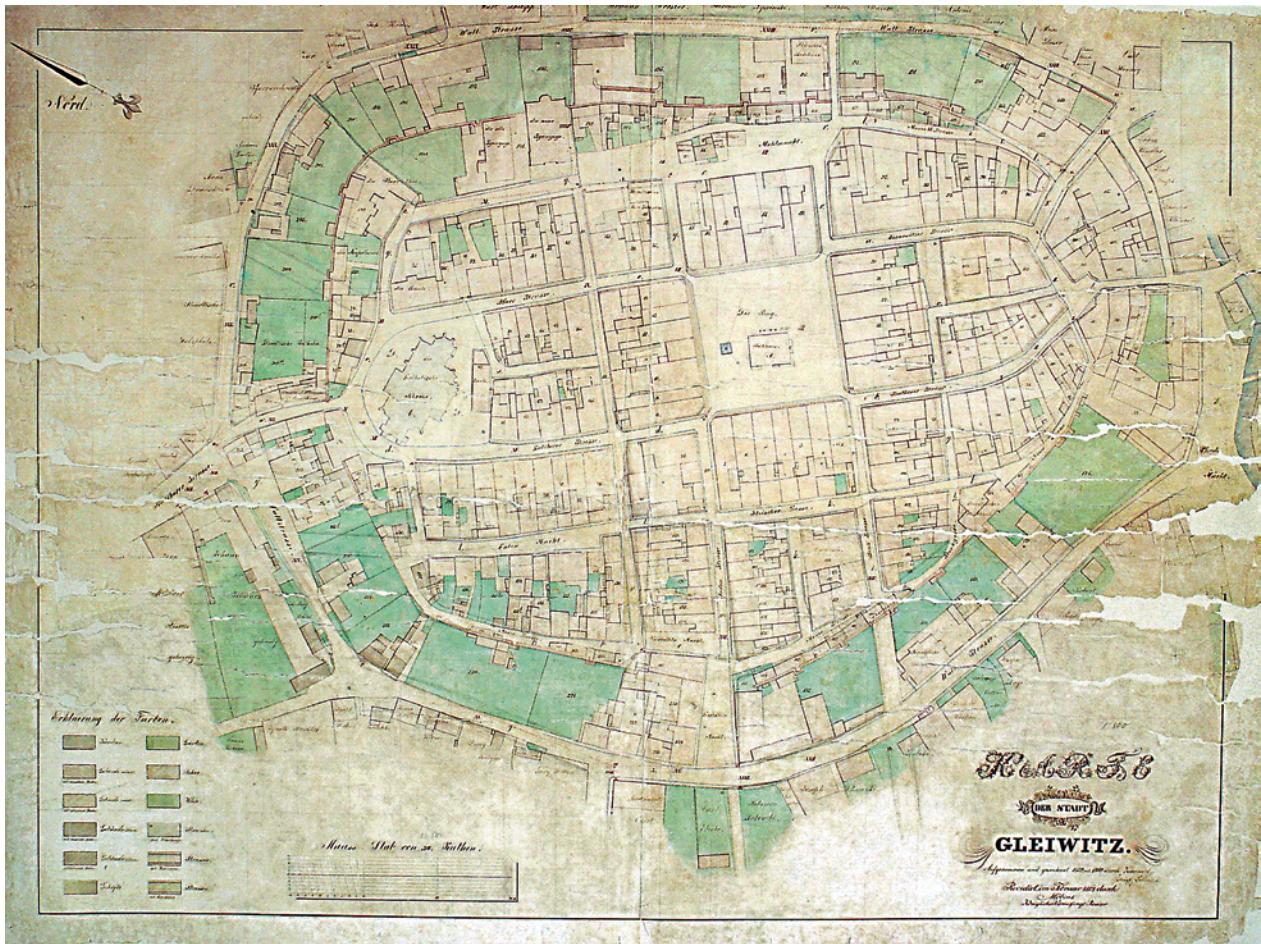
Fig. 10. Gliwice. The town plan from 1861. State Archive in Gliwice

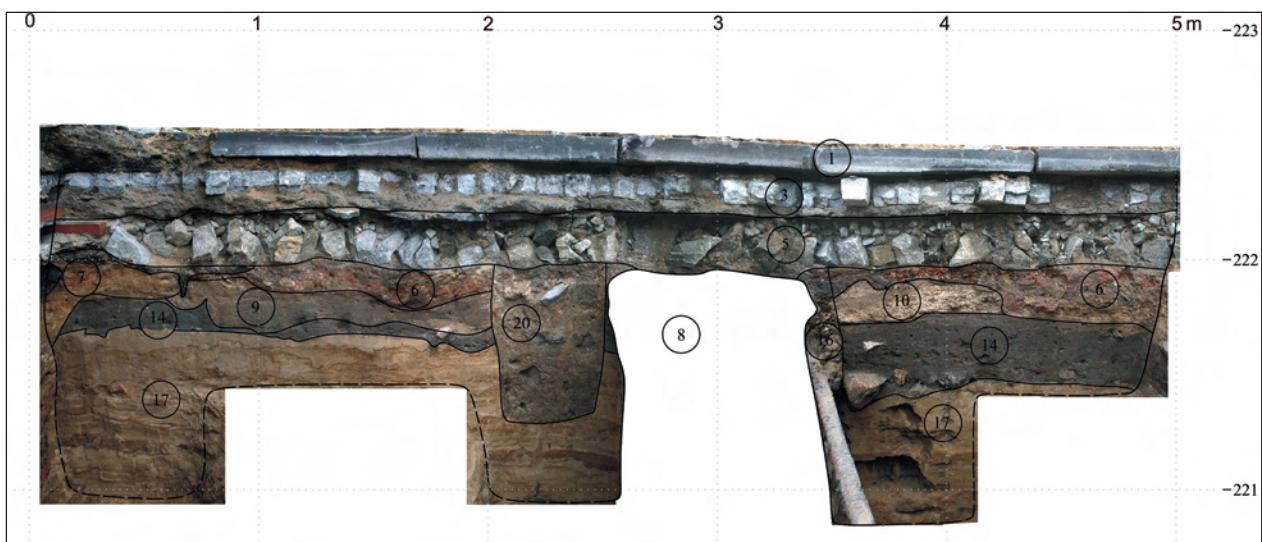
Critical analysis J. Nastaszyc

Fig. 13. Gliwice, Market Square. Sondage trench no. 1. Composite photograph of E section: stratigraphic units (s.u.) 1–5 – modern pavement and sub-base (20th century); s.u. 6 – brown soil with fine brick debris (17th–18th century); s.u. 7 – brick debris with yellow-orange sand (modern trench excavated to repair the foundations of the Town Hall); s.u. 8 – extension of the Town Hall (16th century); s.u. 9 – brown humus; s.u. 10 – lime mortar (building layer s.u. 8); s.u. 16 – trench excavated for a service line (s.u. 15); s.u. 20 – modern cut feature; s.u. 14 – grey humus (13th–14th century); s.u. 17 – yellow sand (natural layer).

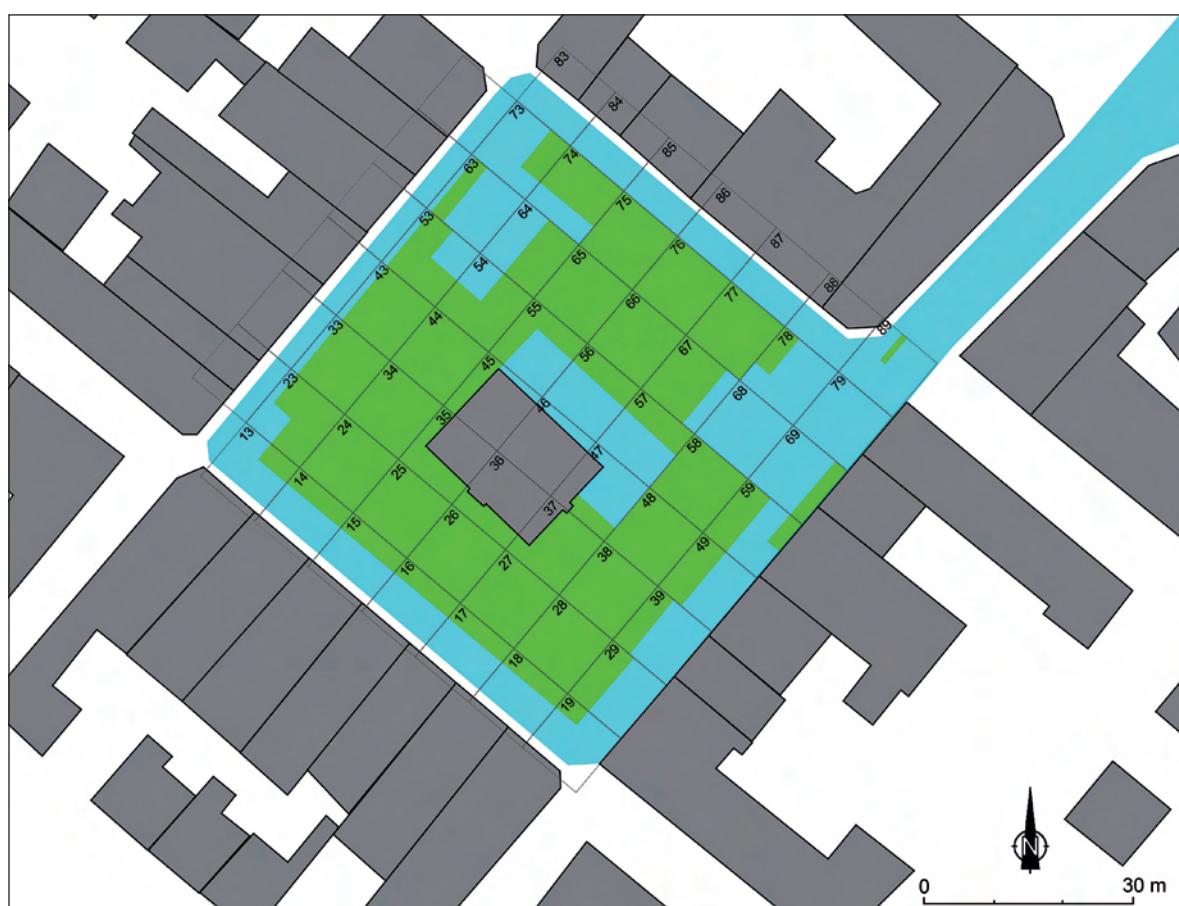
Critical analysis M. Furmanek

Fig. 14. Gliwice, Market Square. Area investigated archaeologically in 2010. The green colour marks the area of the rescue excavation, the blue colour – the area lost to infrastructural systems, subjected to archaeological supervision.

entire open area of the Market Square, except for a 5 m–6 m wide strip along all its frontages, which has been destroyed by the network of subterranean infrastructure (Fig. 14). Only by the eastern frontage of the Market Square did the fieldwork directly reach the line of the buildings (in this case, their arcades). In addition, an archaeological-architectural study was made of the foundations of the Town Hall building exposed during insulation work carried out on the walls.
