II. CHANGES IN THE MARKET SQUARE AND THE TOWN HALL, THE 13TH TO THE 18TH CENTURY. A RECONSTRUCTION BASED ON ANALYSES OF THE CULTURAL DEPOSITS AND REMAINS OF BUILDINGS

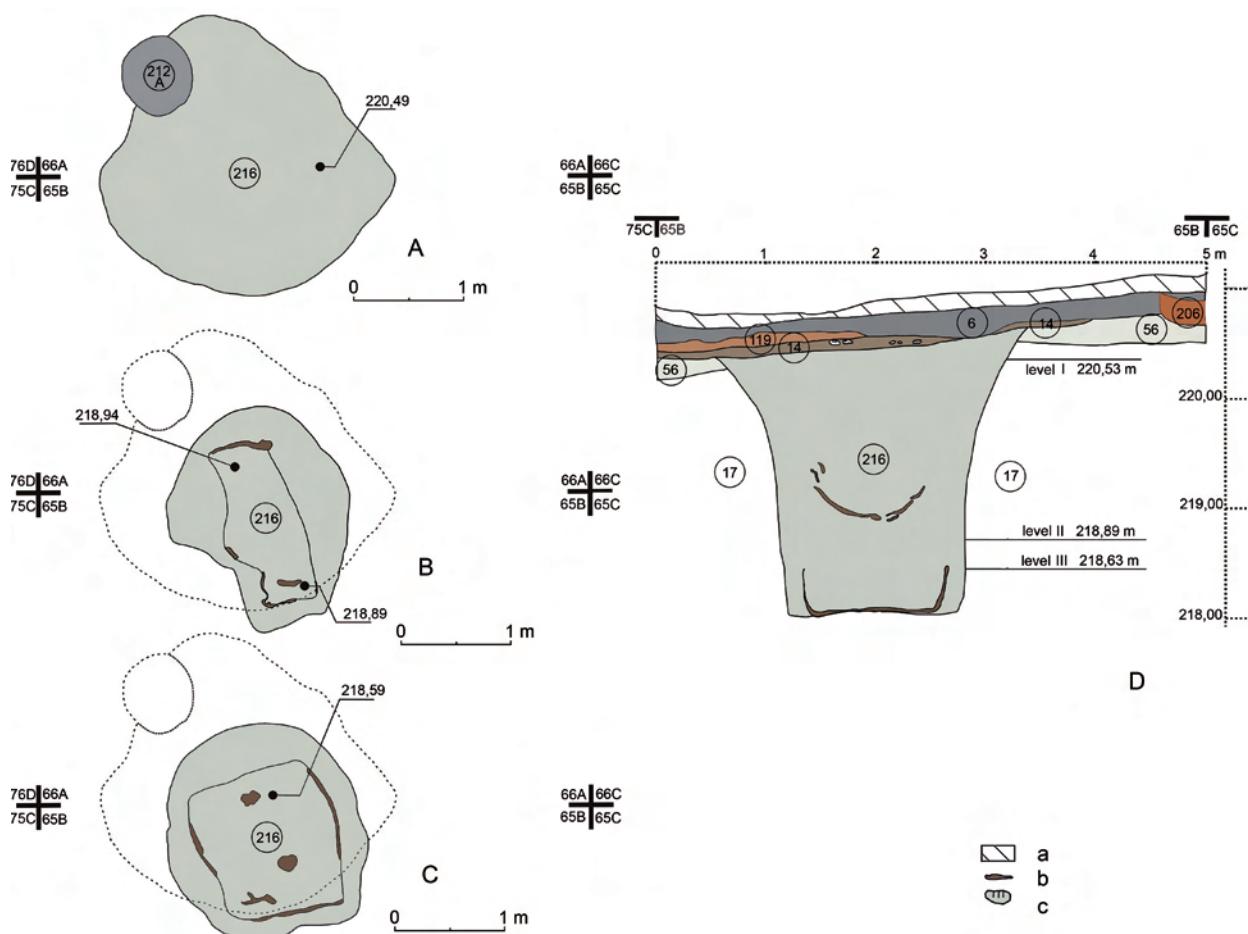
Fig. 15. Gliwice, Market Square, grid sq. 65B/66A. View of the construction of the cellar or water well (s.u. 216):

A – ground plan at the level of detection; B – plan at level II; C – plan at level III; D – W section.

s.u. 6 – brown soil with fine brick debris (17th–18th century); s.u. 119 – grey humus mixed with sand (14th–15th century); s.u. 83 – stone pavement; s.u. 14 – grey humus (13th–14th century); s.u. 206 – brown humus with lenses of yellow sand and fine brick debris (trench excavated for the water supply system), 17th–18th century); s.u. 212A – grey humus with yellow sand (posthole); s.u. 56 – light grey sand of the subsoil; s.u. 17 – yellow sand (natural layer); a – modern pavement, b – wood, c – stone pavement. Fig. A. Młyńska, R. Zdaniewicz

Phase I (see appendix: plan 1) marks the beginning of its functioning and is reflected by several stratigraphic units. The earliest feature identified in the square was a water well, or possibly, a cellar, dug in the northern area of the market (Figs. 15–16). Its age is suggested by its stratigraphic position. This feature did not contain any small finds helpful for determining its origin more closely. The oldest level certain to be associated with a regular use of the square is s.u. no. 14 – a layer of humus that developed when the primary soil became mixed with material introduced during the intensive use of the unpaved surface of the market in conditions of high moisture. The oldest cultural layer survived in large patches over the entire surface of the square and varied in its preservation. It was a few to a dozen-odd centimetres in thickness. Although in some areas, especially in the eastern zone of the square, it could be as much as 30–40 cm in thickness. Presumably, local variations in the composition of this layer are the result of differences in land use in different parts of the square. Locally, in the northern zone its colour was a deep black (s.u. 14/62), the result of a higher content of organic matter (Figs. 17–20). As the muddy conditions in the square became troublesome action was soon taken to have the area paved. This is evidenced by the remnants of the first pavement (s.u. 83) in the form of a layer of pebbles, lumps of sandstone and

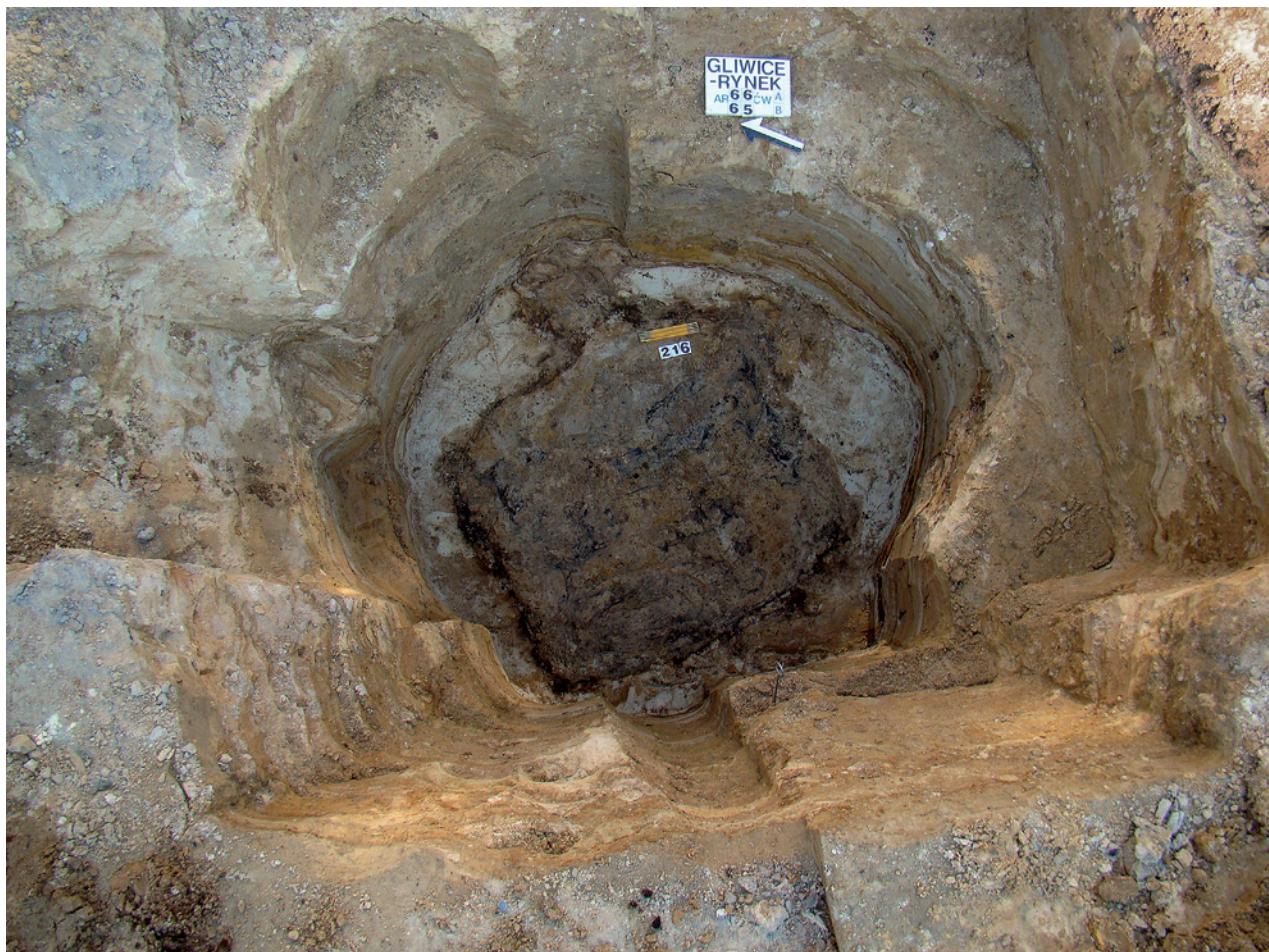
Fig. 16. Gliwice, Market Square, grid sq. 65B/66A. View of the bottom of the feature (s.u. 216) with remains of a wall casing (?) Photograph M. Michnik

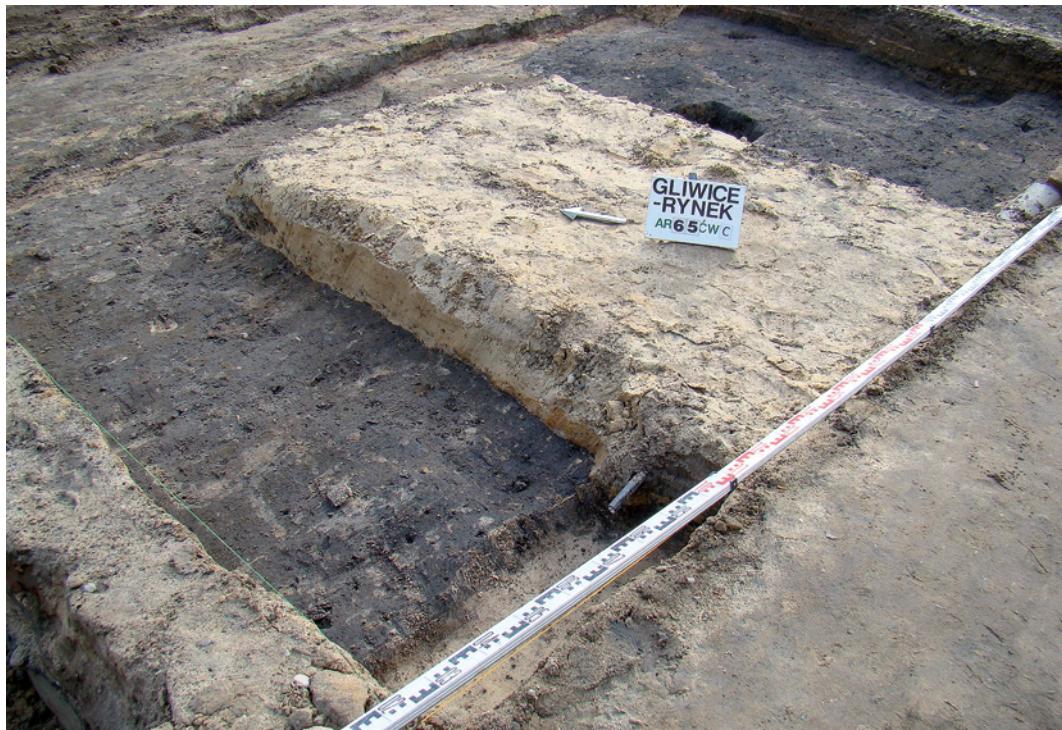
Fig. 17. Gliwice, Market Square, grid sq. 65C. Upper layer of s.u. 14/62. Photograph M. Michnik

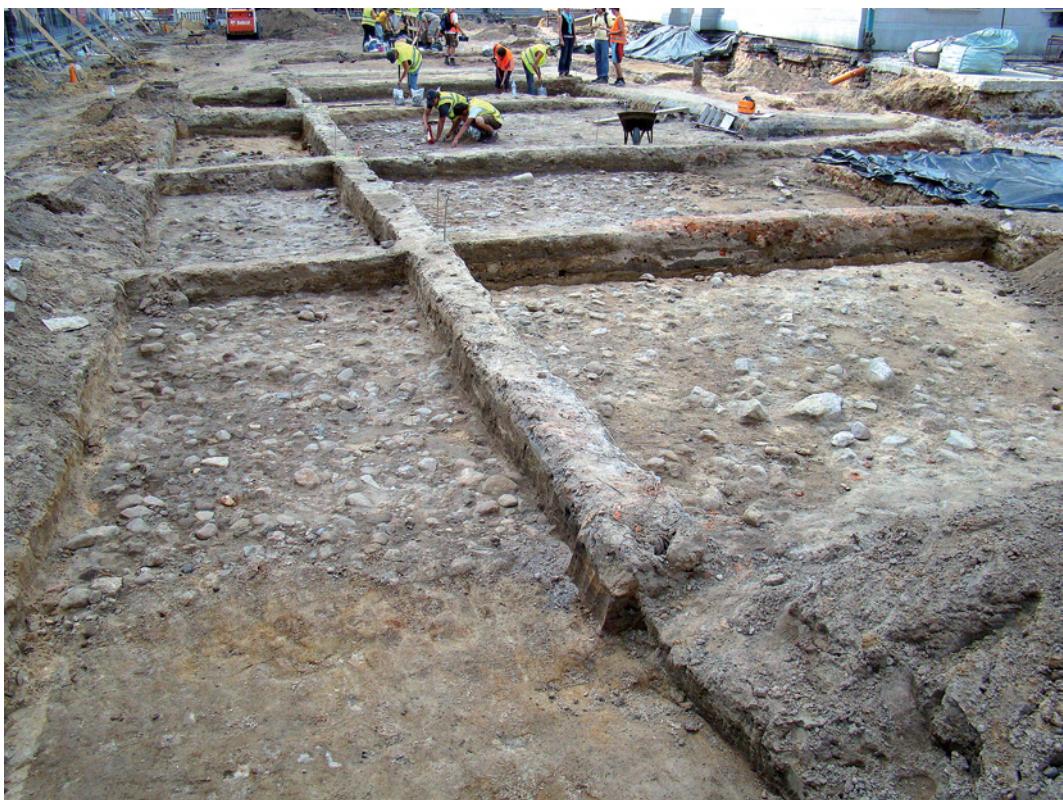
Fig. 18. Gliwice, Market Square, southern area. Cleaning the medieval pavement (s.u. 83). Photograph M. Michnik

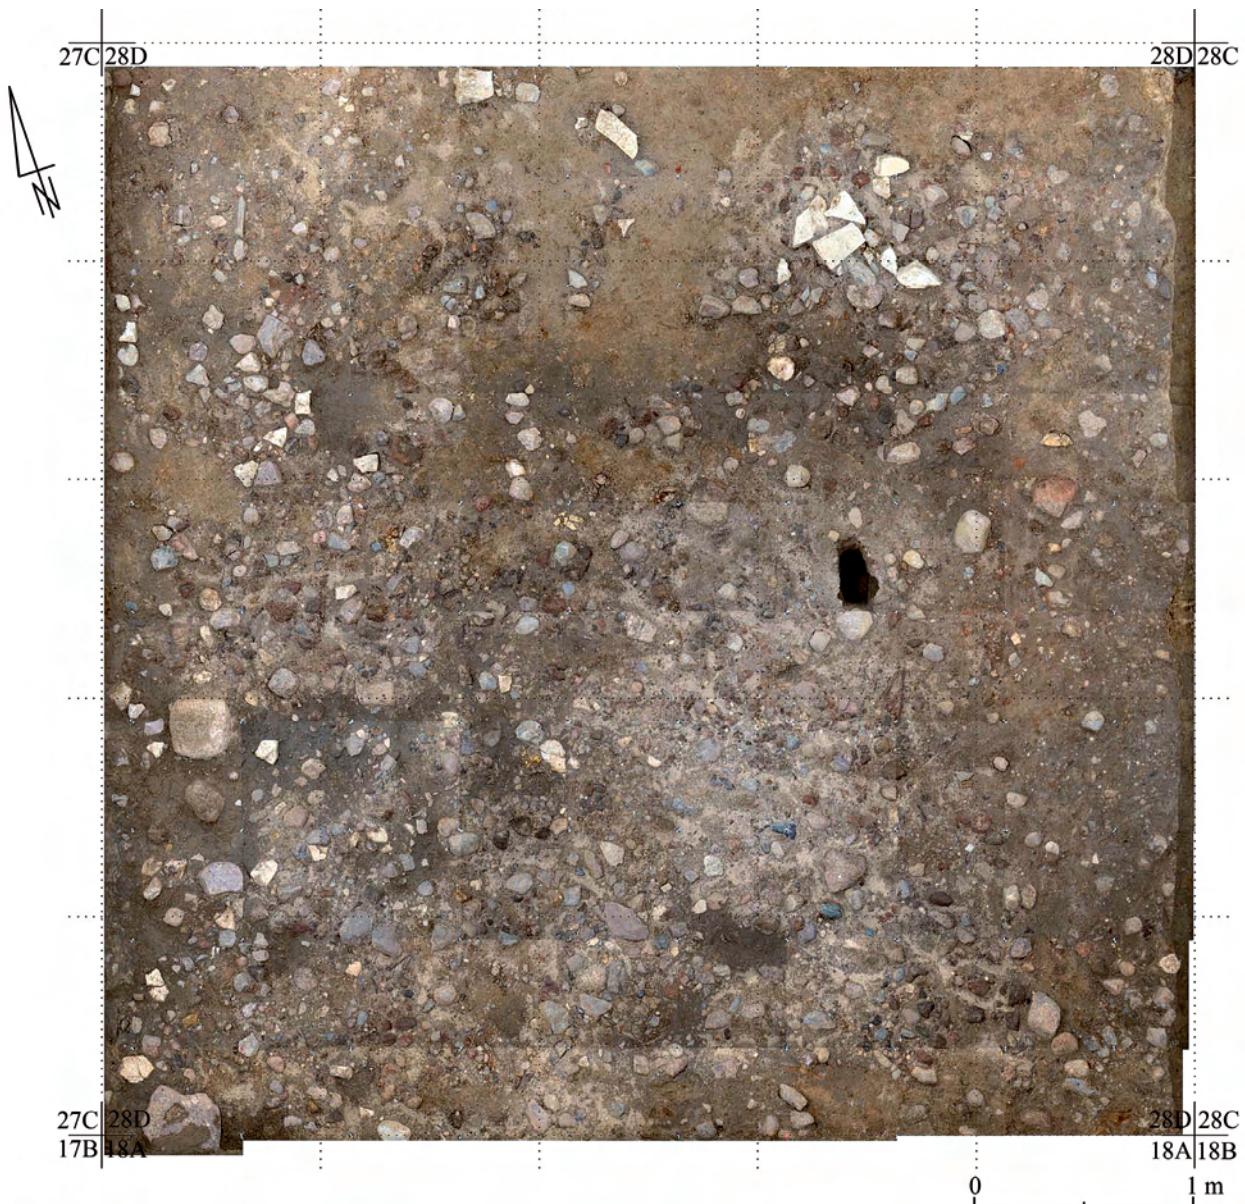
Fig. 19. Gliwice, Market Square, grid sq. 28D. Composite photograph of the pavement (s.u. 83). Critical analysis J. Nastaszyc

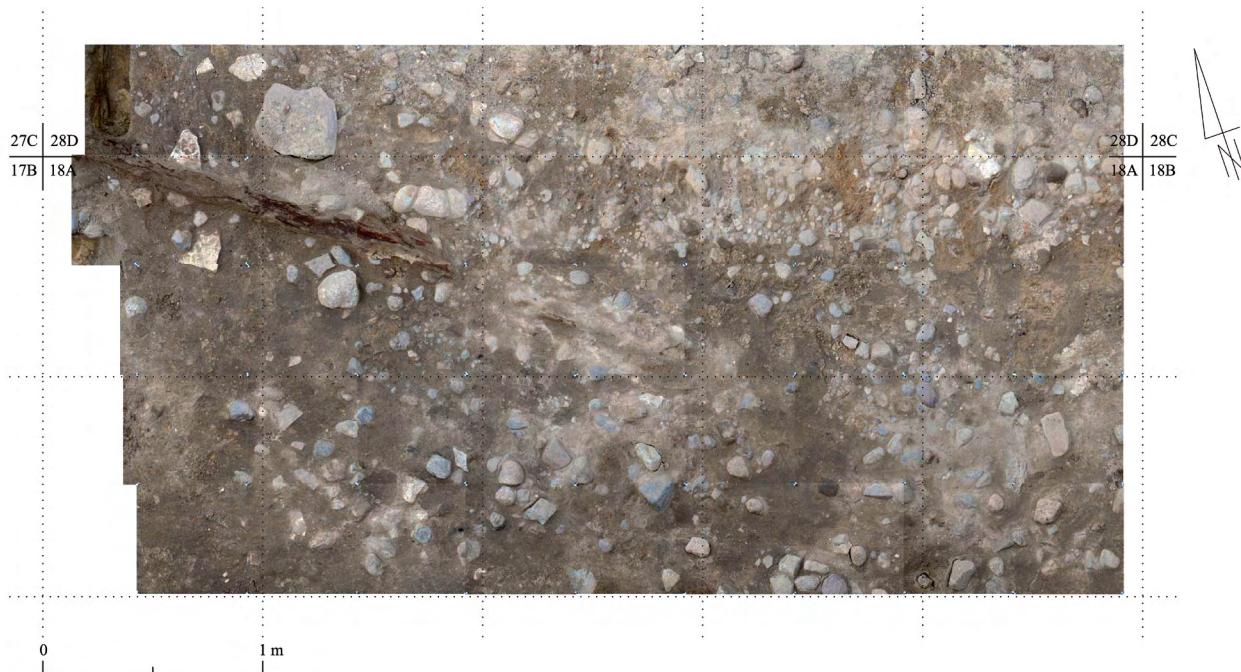
Fig. 20. Gliwice, Market Square, grid sq. 18A. Composite photograph of the pavement (s.u. 83) with the remains of a gutter (s.u. 118). Critical analysis J. Nastaszyc

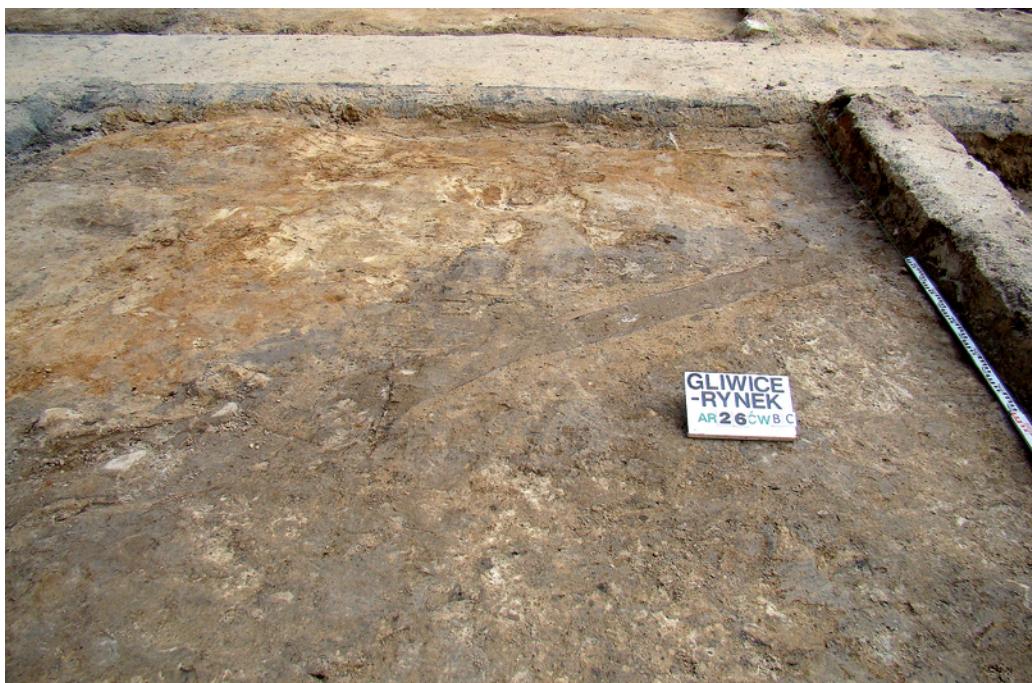
Fig. 21. Gliwice, Market Square, grid sq. 26BC. Upper layer of s.u. 119 with a stain mark from decomposed wood (s.u. 135) (marked with an arrow). Photograph M. Michnik

of mud were covered over with a layer of sand. The result of the mixing of these two deposits is a layer of humus mixed with sand, recorded as s.u. 14A, 14B, 107 and 119. The upper level of one of the layers (s.u. 119) contained many stains from decomposed wood (Fig. 21), suggesting that at least some areas in the square had a timber surface, which was typical in the medieval towns of Central and Northern Europe (Gläser 2004; Piekalski, Konczewski 2010).

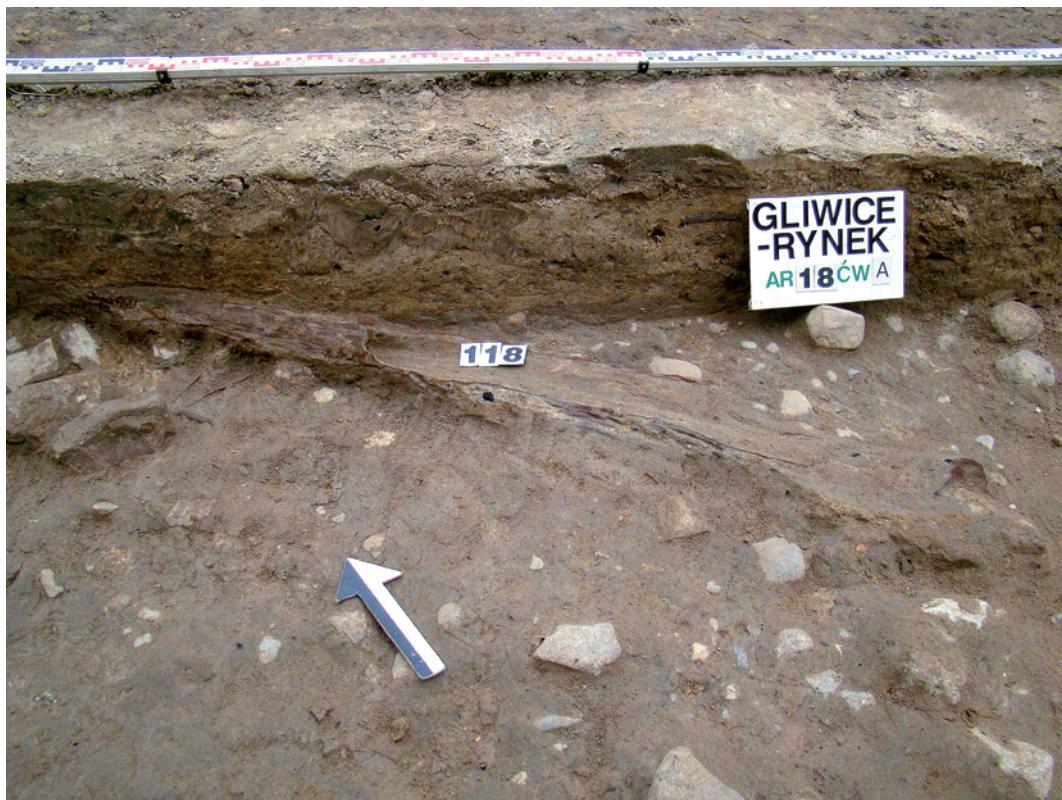
Fig. 22. Gliwice, Market Square, grid sq. 18A. Remains of a wastewater pipe (s.u. 118).
Photograph M. Michnik

With this phase, we can link a number of features typical for a marketplace. Their presence is evidenced by post-holes from the wall timbers or elements supporting the roofs of lightweight post structures, interpreted as market stalls. The better-preserved sequences of post-holes were approximately rectangular in plan, and up to a dozen-odd square metres in area. They were identified mainly in the southern (s.u. 41A–C, 80A–B, 132A–O and 171A–I), western (s.u. 192 A–F', 194 A–G and 195A–I) and northern area of the Market Square (s.u. 68A–J, 199A–B, 202, 213A–E', 219A–M, 152A–E and 156B–F). The absence of similar traces in the eastern zone could be due to the poor level of preservation of the stratigraphic sequence. Other features include a number of solitary post-holes, a few pits of obscure function (s.u. 138), and remains of gutters which drained off wastewater (s.u. 118, 135 and 192R, Fig. 22).

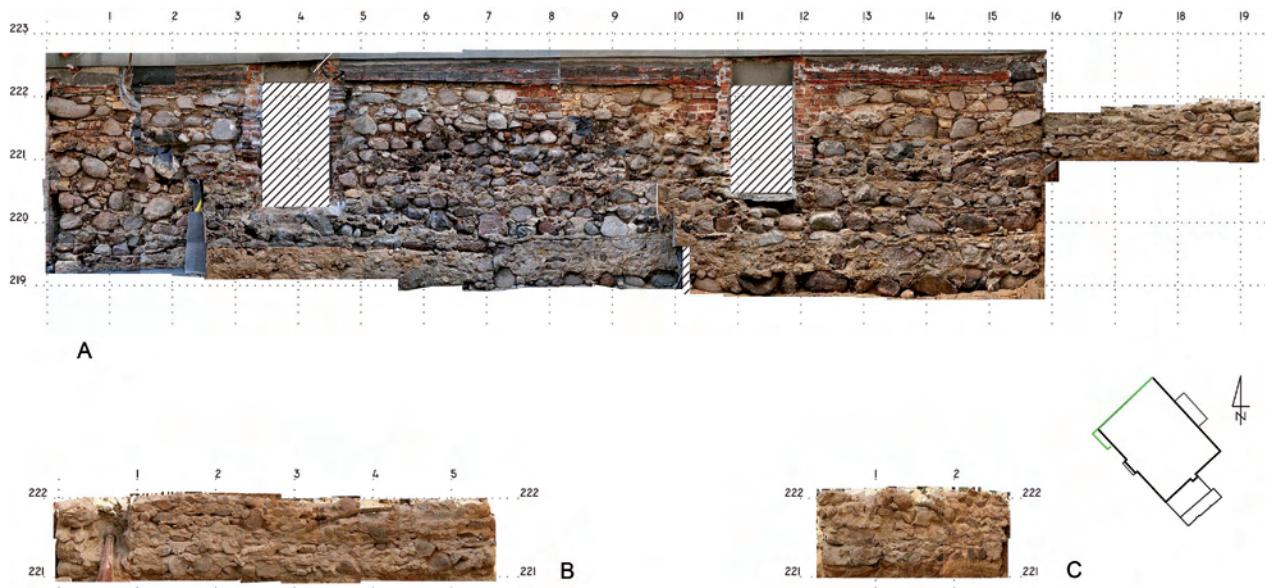
Fig. 23. Gliwice, Market Square, grid sq. 35A/45D. Composite photograph of the foundation of the west wall of the Town Hall. Critical analysis J. Nastaszyc

15.10 m × 19.90 m, its longer axis orientated east to west. The test trench exposed the outer face of the foundations of its southern wall and long stretches of its eastern and western wall (Fig. 23). The trench dug for the foundation extended from the top level of the medieval layers, marked as s.u. 14 and 119, to a depth of more than 3 metres. Measured from the modern ground level in the Market (2010), the depth was on average 3.45 m, with minor differences in individual sections. The wall of the foundation had been laid inside a narrow trench. Only in its top part, the last 75 cm, did it widen considerably. Building material consisted of glacial boulders, yellow sandstone and lime mortar. The foot of the foundation is comprised of large boulders that form a c 35 cm thick layer,

which was levelled at the top using smaller stones. Higher up, the foundation wall also has a layered structure, and the thickness of individual layers is not uniform, ranging from 43 cm to 55 cm. The layers were of rough pebbles laid, if possible, with their flat surface facing up. The largest of these surfaces were 62 × 37 cm, 53 × 30 cm and 44 × 35 cm in

size. The spaces between the boulders were filled in with smaller stones, lumps of yellow sandstone and broken bricks. This material was bonded with mortar made of lumpy lime and filler that gave it a creamy hue. The mortar overflowed from the joins between the boulders on their outside face in a manner typical of masonry laid directly inside a narrow trench.

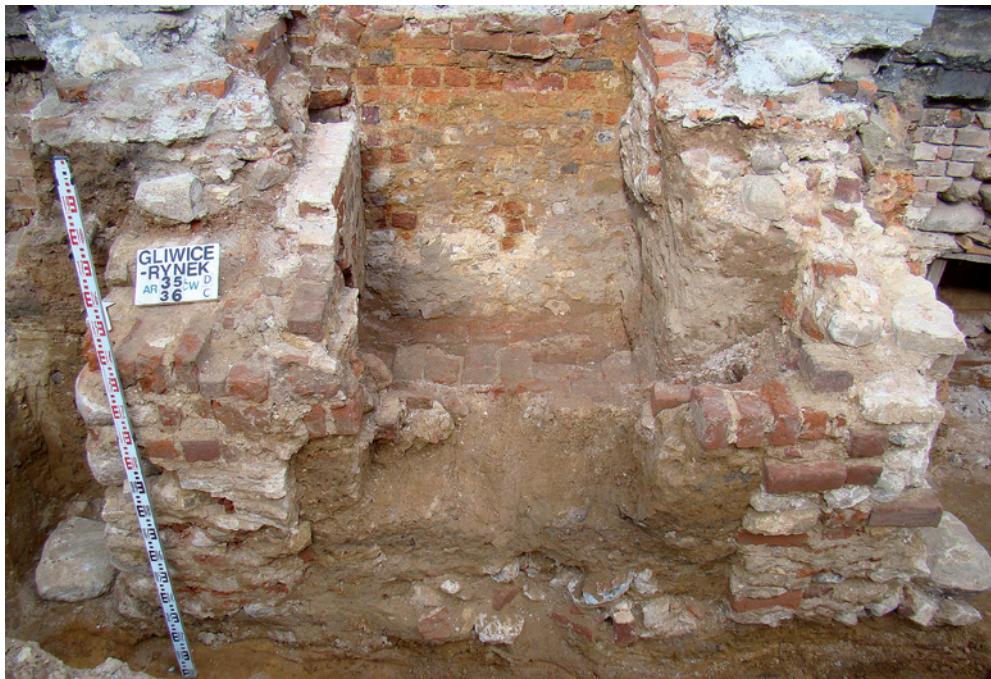
Fig. 24. Gliwice, Market Square, grid sq. 36D. The medieval entrance to the Town Hall (s.u. 170). Photograph M. Michnik

In the southern wall of the Town Hall we identified the original entrance down to its lowest level (Figs. 24, 27–28). It was 9.70 m away from the south-west corner and 8.60 m away from the south-east corner. The construction of the outer staircase was contained

in a trench directly adjacent to the face of the southern wall. It was rectangular in plan, 3.9 m (east to west) × 1.95 m (north to south), its depth, measured from the top of s.u. 14, was about 1.12 m (2.1 m from the present-day level in the Market Square). At the

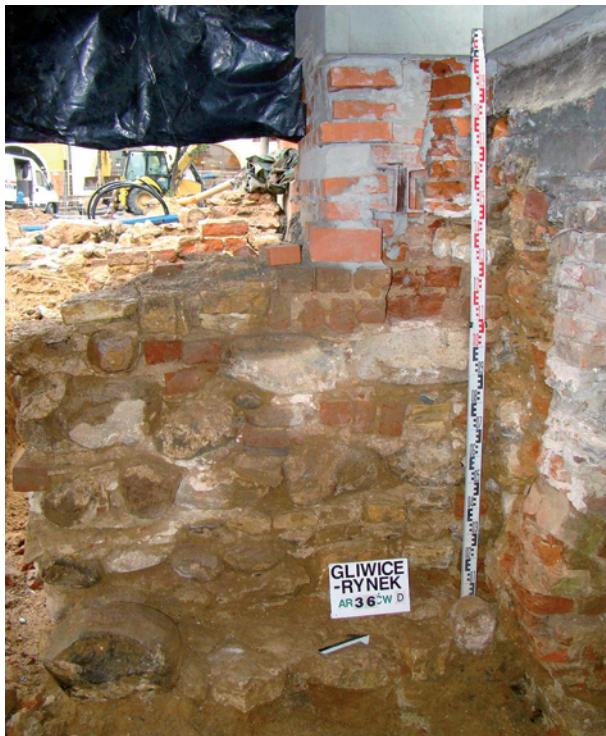
Fig. 25. Gliwice, Market Square, grid sq. 36D. Eastern retaining wall of the staircase (s.u. 170), east section. Photograph M. Michnik

edges of the trench for the staircase, at right angles to the walls of the Town Hall, retaining walls were laid. The base of the eastern wall was 1.12 m wide (Fig. 25) and was built of a single layer of boulders and bricks bonded with mortar. Higher up, the wall was less wide, at 0.8 m, with a 0.45 m wide offset left by the outer face. It was built of pebbles, whole and fragmented, their size in the wall face: 39 × 32 cm, 41 × 22 cm, 41 × 22 cm, and smaller; flat pieces of split sandstone (up to 9 cm thick and bricks measuring 9; 9.5; 94 × 13, 12.8 × 27–26.5 cm. They were bonded with lime mortar, yellow to cream-coloured, with some lumps of unslaked lime evident. The retaining wall by the western edge of the trench for the staircase had a similarly laid footing. It was 1.1 m wide, higher up; the wall had a thickness of about 0.76 m. It was built of similar material and using methods similar to those used in building the eastern wall. The open areas of the trench had been backfilled with light brown clayey humus containing a great quantity of sand, brick debris and small lumps of lime mortar. The bottom level of the inside of the trench had been spread with demolition debris consisting of pebbles and broken bricks. The construction of the staircase – five brick steps – was set between the retaining walls (Fig. 26). The size of the steps corresponds to the length of a brick, i.e. about 28 cm. The width of the interior of the staircase was 1.6 m and corresponded to the width of the entranceway. At the top, the doorway had a pointed arch, of which five bricks from its western section now survive. The masonry

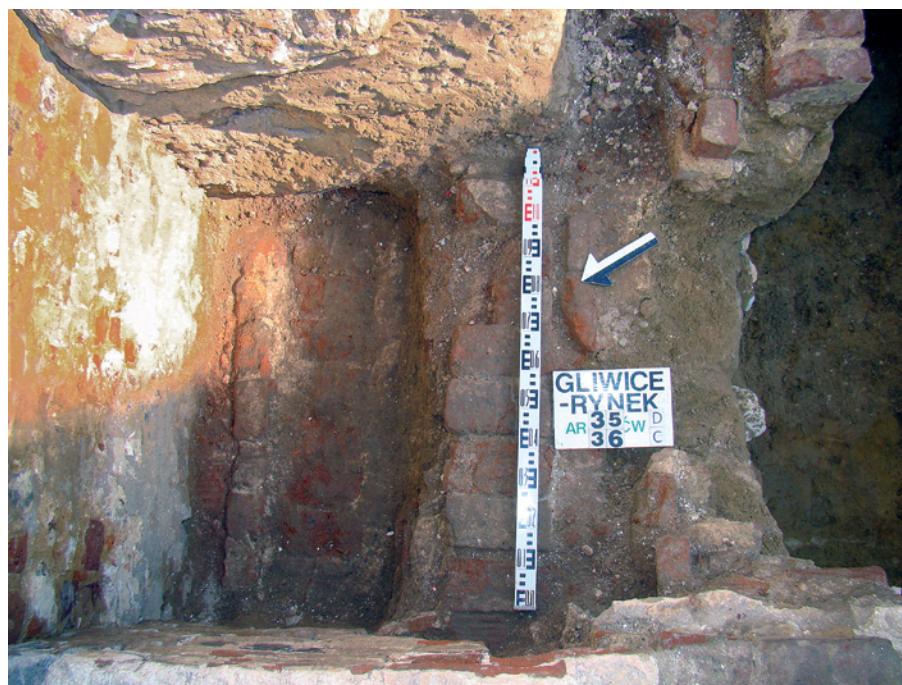
Fig. 26. Gliwice, Market Square, grid sq. 36D. Remains of the brick construction of the stairway (s.u. 170). Photograph M. Michnik

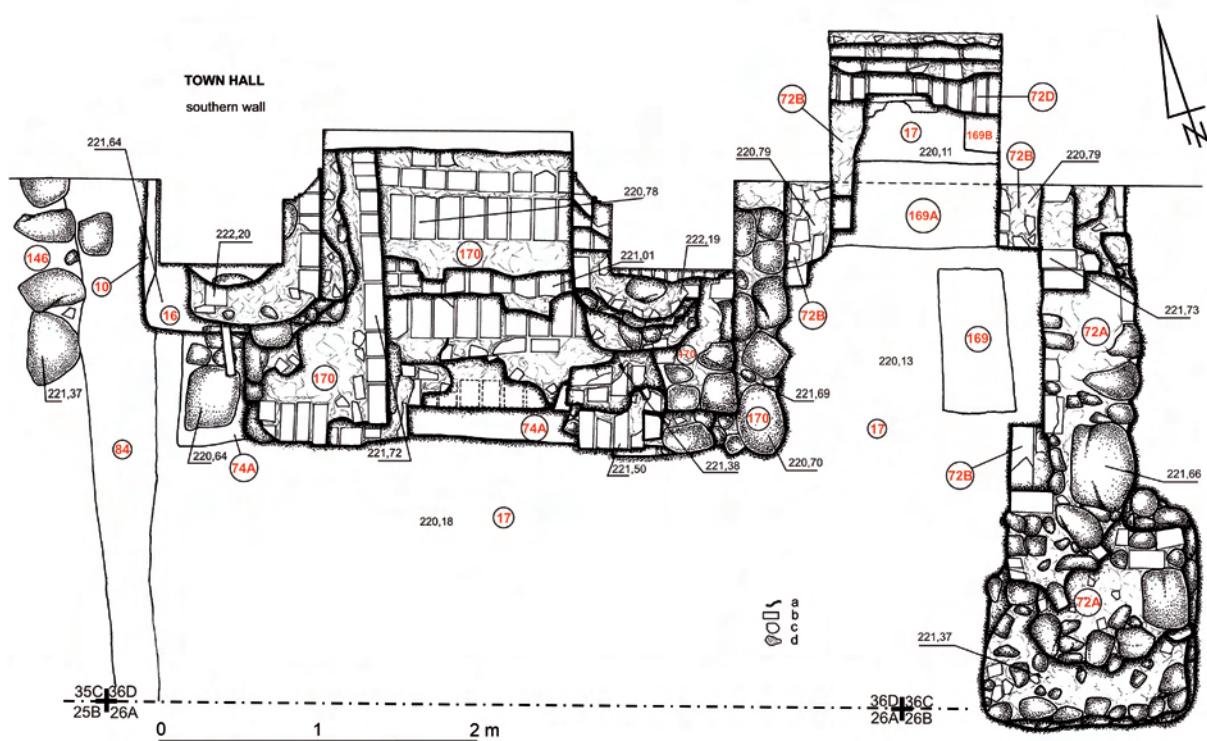
Fig. 27. Gliwice, Market Square, grid sq. 36D, C. The medieval entrance to the Town Hall (s.u. 170) and modern period entrances to the Town Hall cellar (s.u. 72). Plan of: s.u. 10 – lime mortar (construction layer of the wall s.u. 8); s.u. 16 – trench excavated for a service line; s.u. 72 – modern construction associated with the entrance to the Town Hall cellar: s.u. 72A – construction phase I (17th–18th century), s.u. 72B – Phase II, s.u. 72D – Phase IV (2nd half of the 19th century); s.u. 146 – modern period trench excavated when improving the Town Hall; s.u. 169, 169A, 169B – trenches excavated when building the staircase (s.u. 72); s.u. 74A – trench associated with s.u. 170; s.u. 170 – the medieval entrance to the Town Hall; s.u. 84 – modern installations trench; s.u. 17 – yellow sand (natural layer); a – differences in levels, b – brick, c – stone, d – lime mortar.

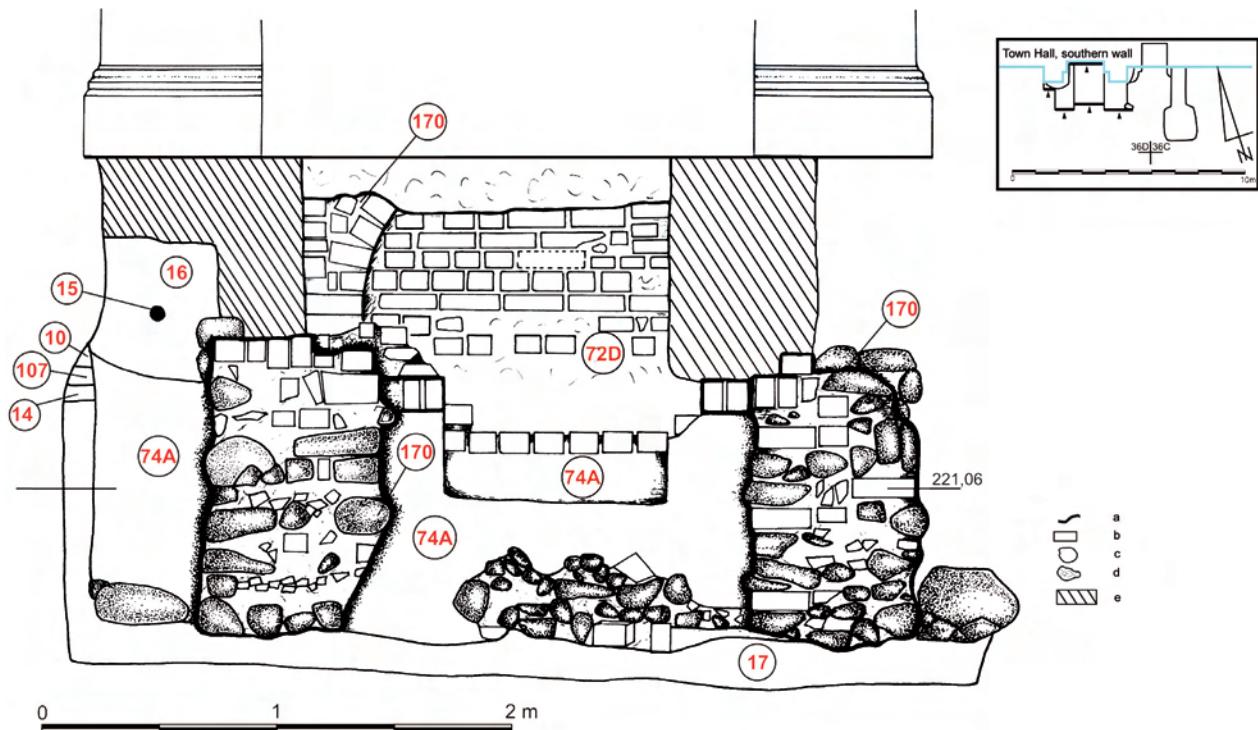
Fig. 28. Gliwice, Market Square, grid sq. 36D. The medieval entrance to the Town Hall (s.u. 170), N section: s.u. 10 – lime mortar (layer associated with construction of the wall, s.u. 8); s.u. 14 – layer of grey humus (13th–14th century); s.u. 15 – power line; s.u. 16 – trench excavated for a service line; s.u. 72D – construction phase IV (2nd half of the 19th century); s.u. 107 – layer of maroon-coloured humus; s.u. 74A – trench associated with s.u. 170; s.u. 170 – the medieval entrance to the Town Hall; s.u. 17 – yellow sand (natural layer); a – differences in levels, b – brick, c – stone, d – lime mortar, e – destroys area. Drawing A. Młyńska

stairway were set between retaining walls. The whole structure was repaired a number of times (Figs. 37; 38; see also Fig. 28)).

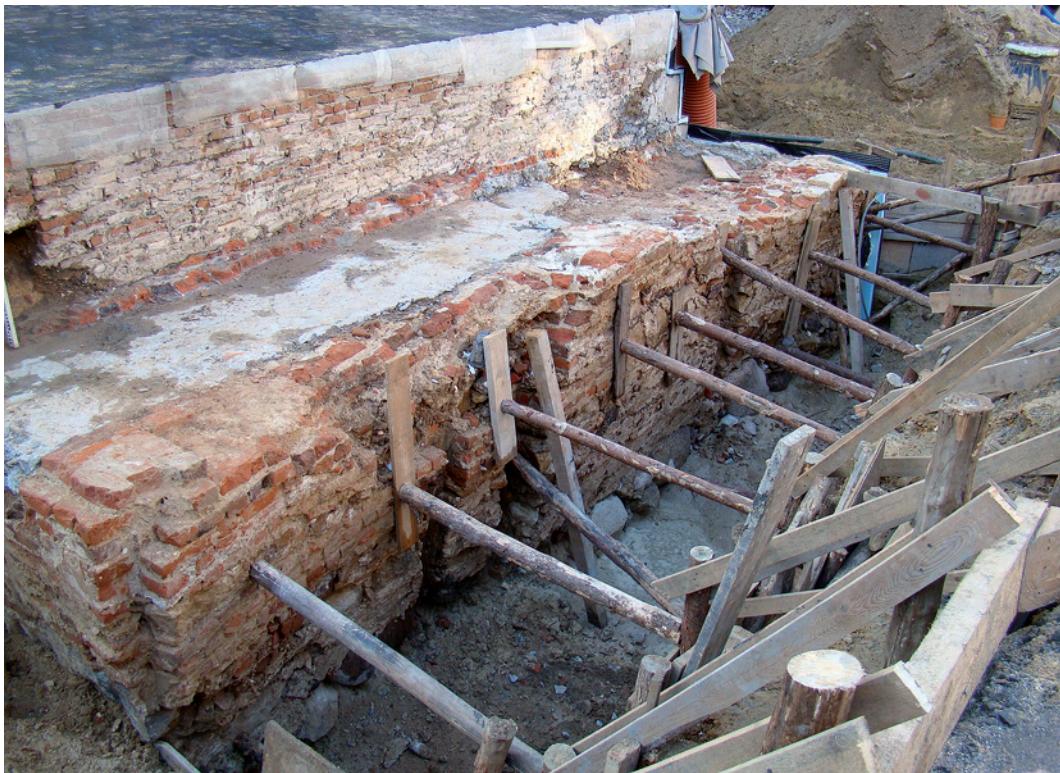
Fig. 29. Gliwice, Market Square, grid sq. 37. The lower storey of the extension of the Town Hall (s.u. 174).
Photograph M. Michnik

The eastern wall of the Town Hall, by its south-east corner, was provided with an extension (s.u. 174) rectangular in plan, its outer dimensions 6.9 m (south wall), 8.65 m (east wall) and 6.8 m (north wall) (Fig. 29–31). The thickness of the extension wall, measured in the north at a height of 220.77 m above sea level, was 1.6 m, which made it thicker than the wall of the main building. The lowest storey of the extension was partly below ground level; its interior space survives to the present in the underground part of the Town Hall. The walls of the extension were laid inside a narrow trench, stabilized with a wooden shoring. The outer face of the walls was laid flush with the sides of the foundation trench which had been dug into the natural sand. The shoring was an incomplete openwork of rough planks and vertical and horizontal timbers. Only in the longest, eastern wall did the horizontal elements predominate. They were stabilised by means of three timber uprights. The first of these, set farthest to the

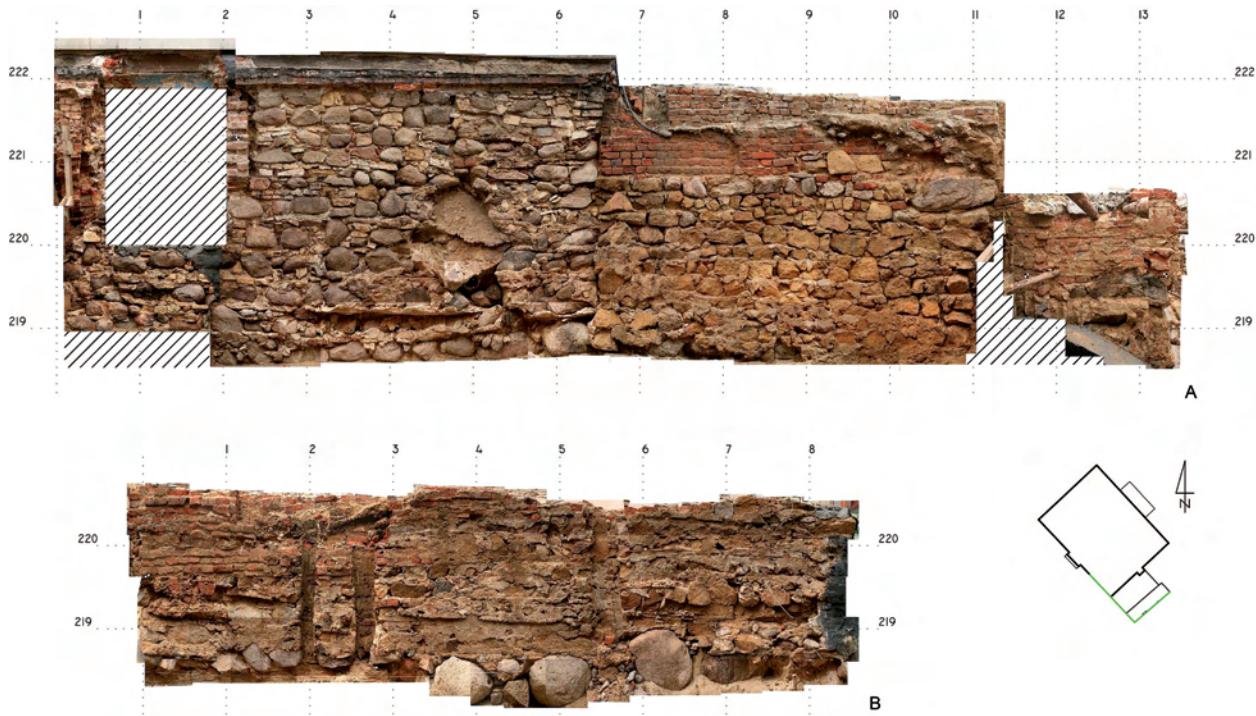
Fig. 30. Gliwice, Market Square, grid sq. 38D, C. Composite photograph of the foundation of the southern wall of the Town Hall (s.u. 39) with extension (s.u. 174) and east section of its foundation. Critical analysis J. Nastaszyc

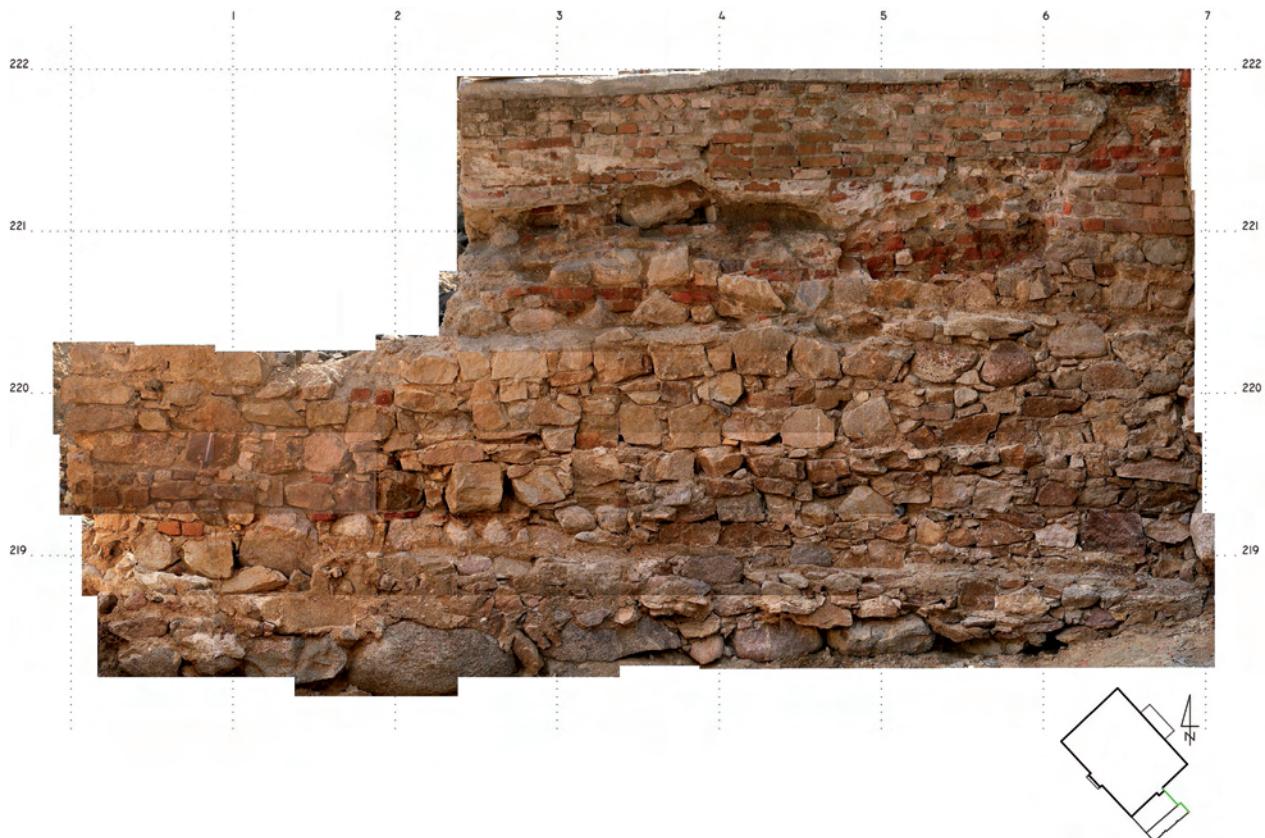
Fig. 31. Gliwice, Market Square, grid sq. 48D, C. Composite photograph of the northern wall of the extension (s.u. 174).
Critical analysis J. Nastaszyc

level of the Market Square, i.e. at 218.30 m above sea level. It was built of glacial boulders, with some care taken to have their level surfaces a part of the wall face. The area of these surfaces is 95 × 26 cm, 98 × 50 cm, 80 × 65 cm, 75 × 65 cm, 40 × 30 cm and similar. Also identified in the foundation base of the southern wall were similarly sized lumps of yellow sandstone. The wall above the foundation base was laid with dressed irregular slabs of the same sandstone with a filling of small pebbles and broken bricks. The arrangement of the flagstones was approximately in layers, their thickness ranging between 24 cm and 37 cm. The sandstone slabs were 42 × 20 cm, 40 × 24 cm, 26 × 17 cm, 18 × 18 cm and similar. They were bonded with lumpy cream-coloured lime mortar and mineral filler. At 64 cm above the level of the foundation base, the first offset was laid, changing the thickness of the wall by 15–20 cm. The second offset was identified 1.44 m above the level of the foundation base (79 cm above the first offset), the third, at 2.20 m measuring from the level of the foundation base, or, at 220.50 m above sea level. The width of the second offset was 8–10 cm, of the third – 34–36 cm, above the third offset, the wall was comprised of more bricks.

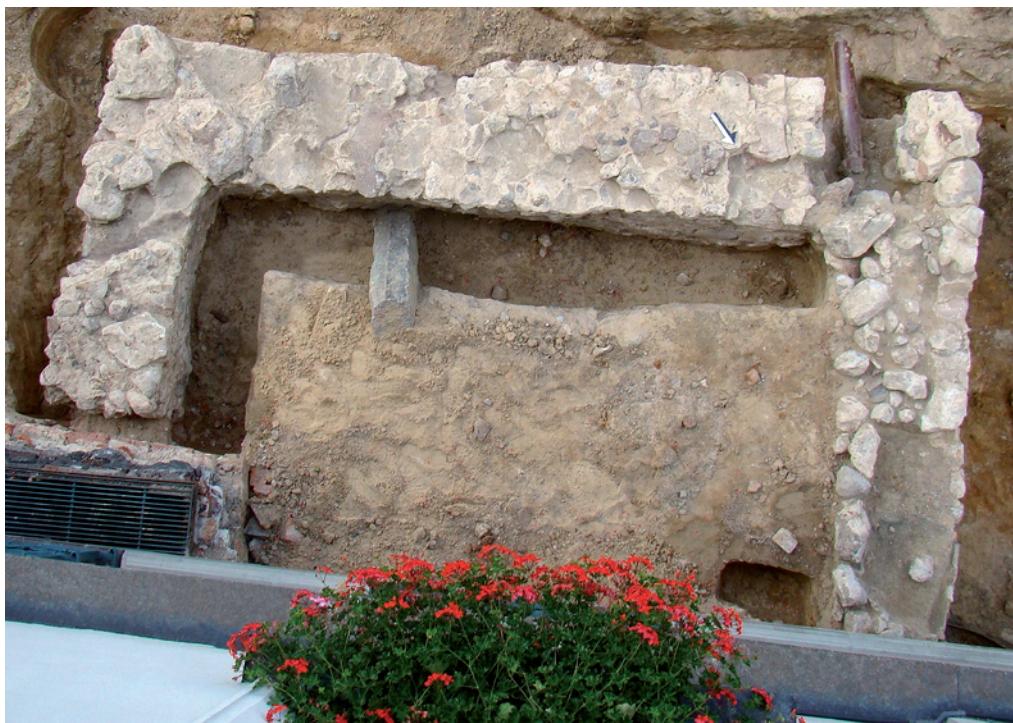
Fig. 32. Gliwice, Market Square, grid sq. 35D, C. Southern extension of the Town Hall (s.u. 8) viewed from above. Photograph M. Michnik

A second extension (s.u. 8) was added to the western stretch of the southern wall of the Town Hall (Figs. 32, 34). Its walls, together with the wall of the Town Hall, which confines it from the north, encloses an area 2.52 m (north to south) × 3.93 m (east to west). All the walls were laid inside a narrow trench, dug 49 cm below the surviving upper level of the natural sand and 97 cm from the upper level of the construction layer. The thickness of the southern wall is 90–100 cm, of the eastern and western, 76 cm and 90 cm, respectively. They were built of both intact and broken pebbles measuring 30 × 26 cm, 30 × 20 cm,

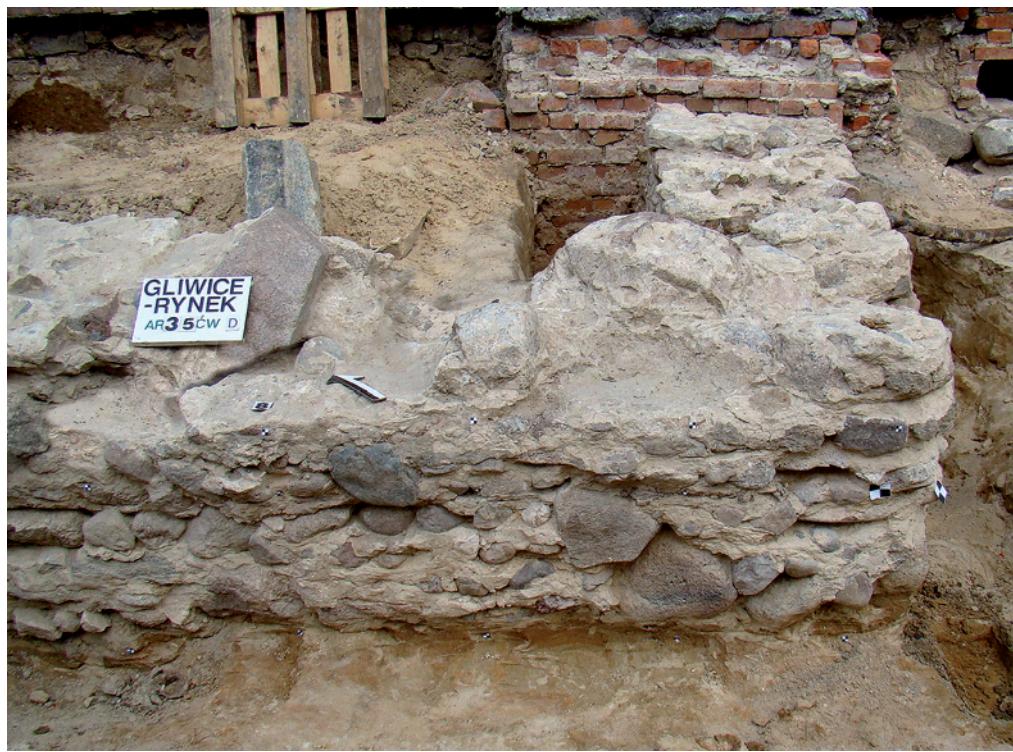
Fig. 33. Gliwice, Market Square, grid sq. 35D, C. Fragment of the southern wall of the extension (s.u. 8), south section. Photograph M. Michnik

25 × 10 cm and smaller, which were bonded with a strong lime mortar, probably slaked inside the trench, but still retaining a small number of lumps. The wall face was formed of natural, less frequently, broken, surfaces of the stones (Fig. 33). The interior has no cellar. Its occupation level is designated by a surviving fragment of a stone pavement, presumably its floor, loosely laid of fieldstones ranging in diameter between 8 cm and 20 cm.

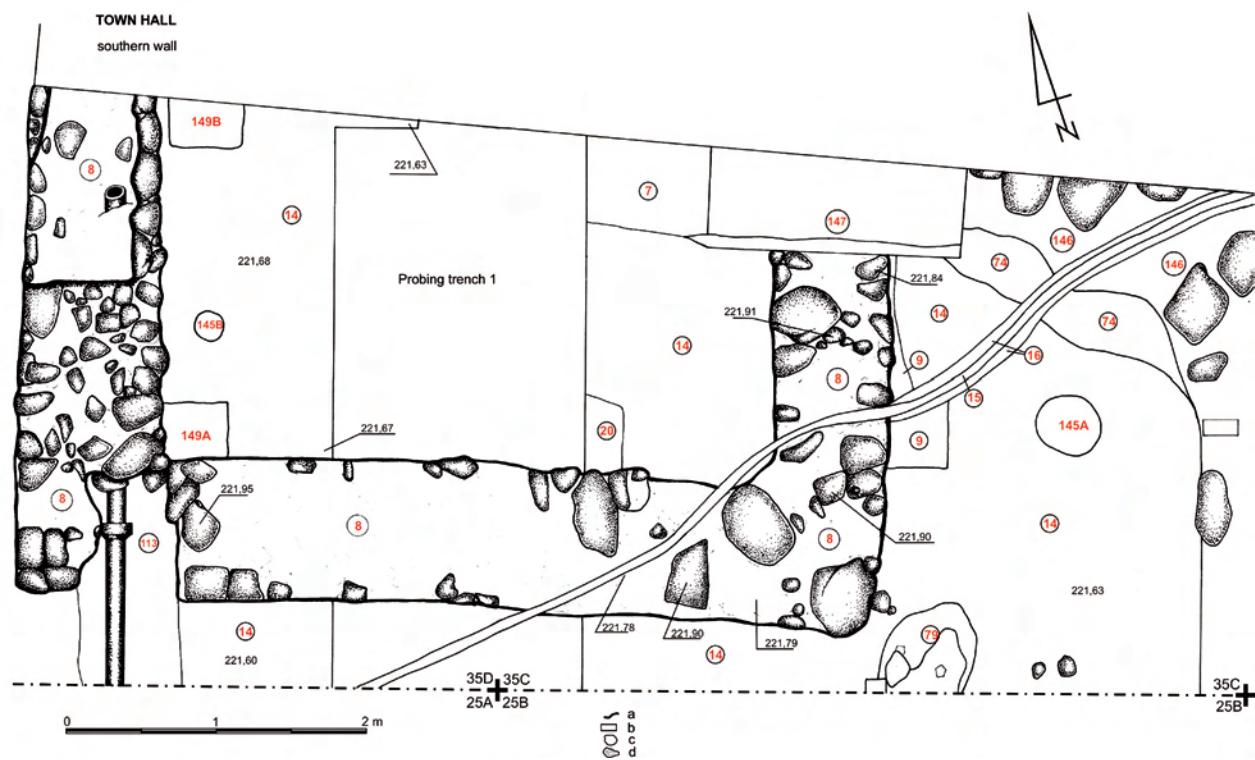
Fig. 34. Gliwice, Market Square, grid sq. 35D, C. Southern extension of the Town Hall (s.u. 8). Plan of: s.u. 7 – modern trench excavated to repair the foundations of the Town Hall; s.u. 8 – stone wall of the extension (16th century); s.u. 9 – brown humus mixed with brick debris; s.u. 14 – grey humus (13th–14th century); s.u. 15 – service line; s.u. 16 – trench excavated to lay the service line (s.u. 15); s.u. 20, 79, 113, 147 – modern cut features; s.u. 74 – cut feature associated with s.u. 72; s.u. 145A, 145B – postholes; s.u. 146 – modern cut feature associated with improvements made to the Town Hall; s.u. 149A, 149B – modern cut features; a – differences in levels, b – brick, c – stone, d – lime mortar.

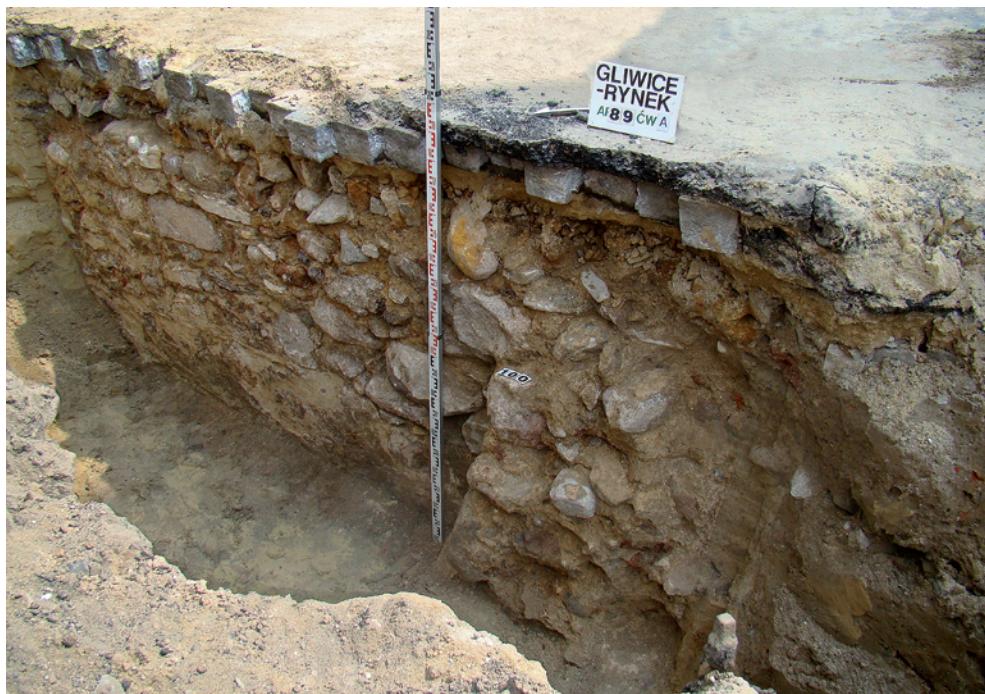
Fig. 35. Gliwice, Market Square, grid sq. 89A. Remains of the foundations of a town house (s.u. 100) identified in the northern frontage, now in Zwycięstwa St. Photograph M. Michnik

Parallel to the extension of the Town Hall, residential buildings were built around the Market Square. This is evidenced by the remains of a town house discovered on the eastern edge of the northern frontage (s.u. 100). One of its elements was a section of a cellar built of glacial pebbles and with a fill of broken sandstone and brick, in a technique similar to the one used in the Town Hall building (Fig. 35). The inner face of the cellar wall was given a sort of a rudimentary plaster finish by spreading it with the mortar, which had seeped from the joins between the stones. We know that the western wall, from the
