II. CHANGES IN THE MARKET SQUARE AND THE TOWN HALL, THE 13TH TO THE 18TH CENTURY. A RECONSTRUCTION BASED ON ANALYSES OF THE CULTURAL DEPOSITS AND REMAINS OF BUILDINGS

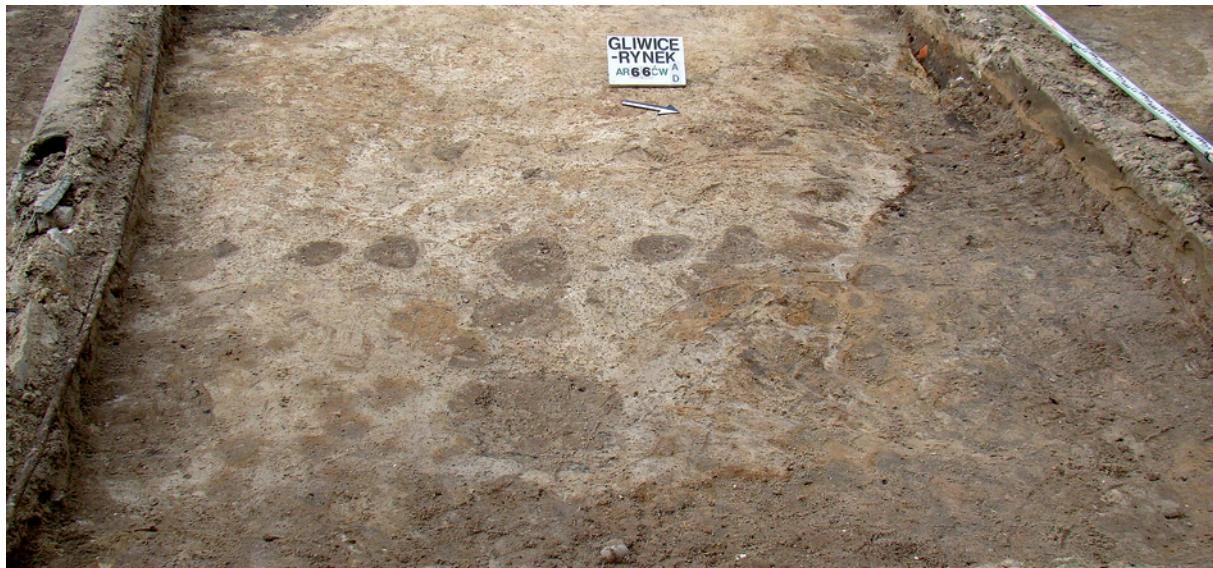
Fig. 36. Gliwice, Market Square, grid sq. 66A. Remains of a lightweight structure – a market stall (s.u. 208).
Photograph M. Michnik

Observation of the upper level of the sandy layer identified traces of posts, interpreted as the remains of lightweight timber structures, presumably stalls associated with the trading function of the square. Five such structures were identified, one of them (s.u. 92) found in the eastern area of the market, one (s.u. 115A–K) in its south-eastern area, and three (s.u. 153A–C, 165, 211, 208A–W and 212A–B) in the northern area (Fig. 36). The surviving traces indicate that the stalls were rectangular in plan, 5–8 m long and less than 2 m wide. The posts were driven or dug into the ground every few dozen centimetres.

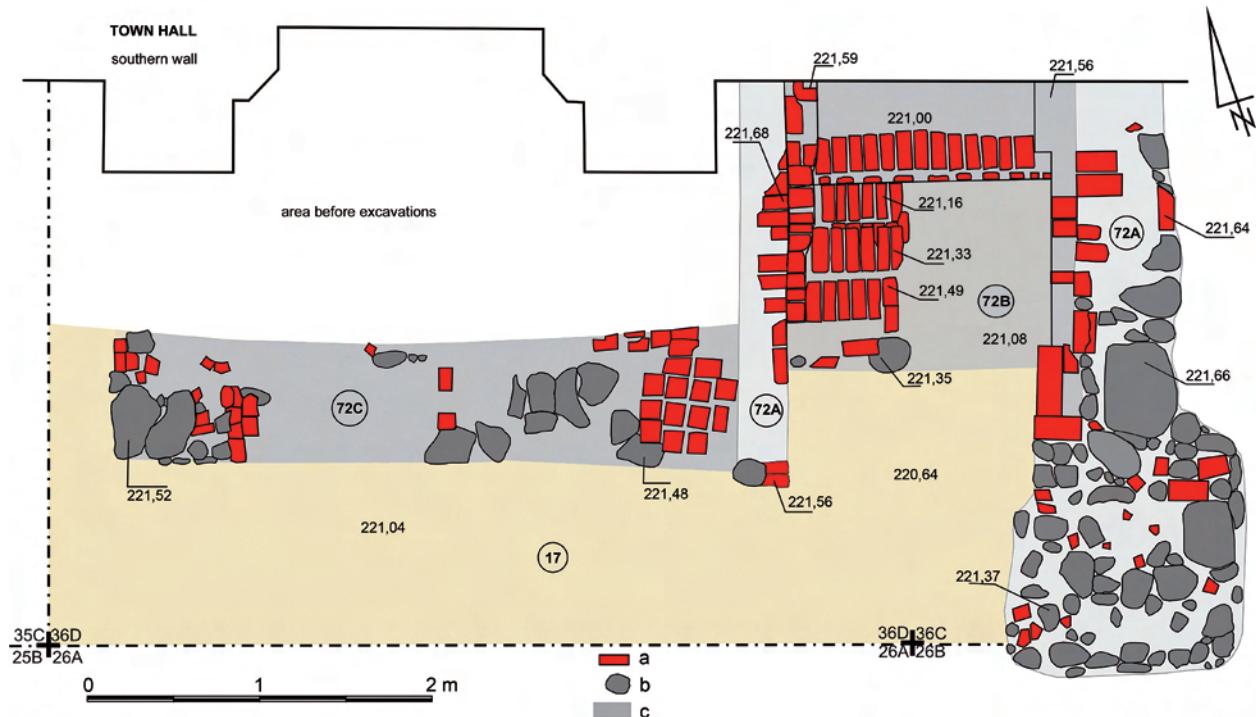
Fig. 37. Gliwice, Market Square, grid sq. 36D, C. Modern period entrances to the Town Hall cellar (s.u. 72). Plan of: s.u. 72 – modern construction associated with the entrance to the Town Hall cellar; s.u. 72A – construction phase I (17th–18th century), s.u. 72B – Phase II, s.u. 72c – Phase III (foundation of a porch to the ground floor of the Town Hall), s.u. 72D – Phase IV (2nd half of the 19th century); s.u. 17 – yellow sand (natural layer); a – brick, b – stone, c – brick-stone mortar.

stairway were set between retaining walls. The whole structure was repaired a number of times (Figs. 37; 38; see also Fig. 28)).

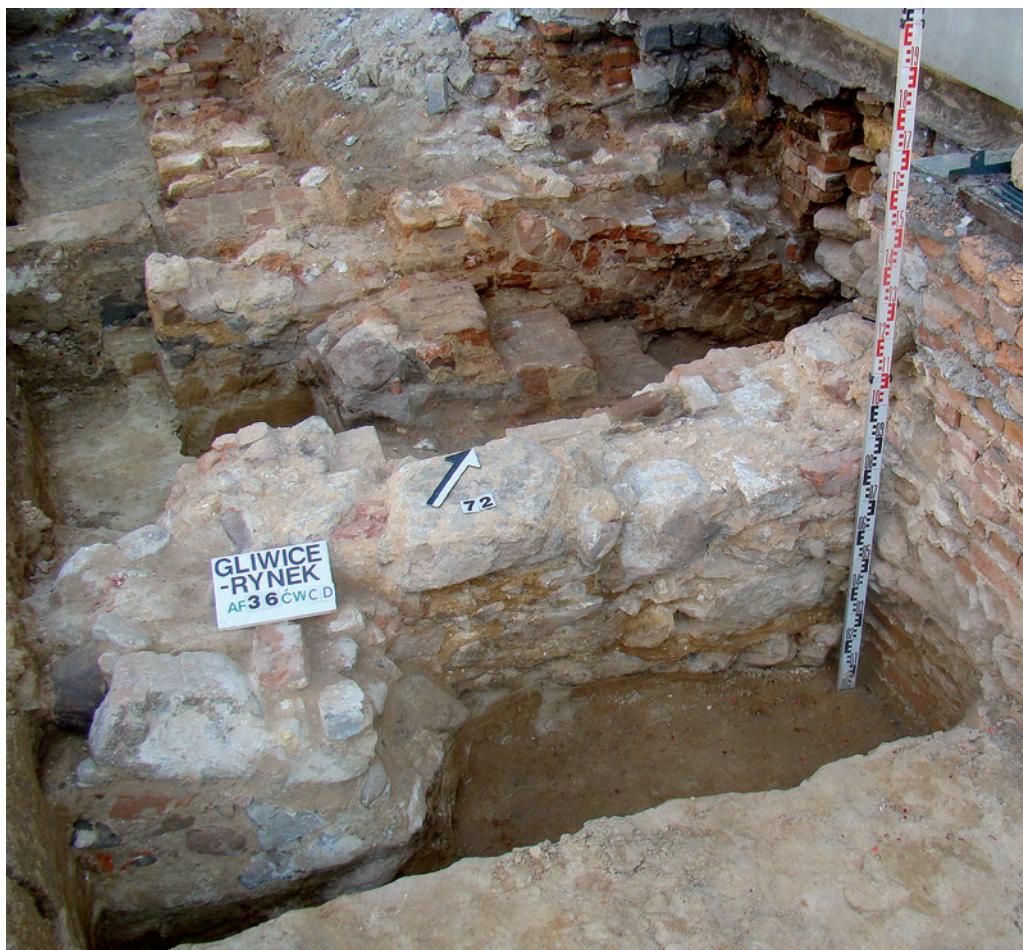
Fig. 38. Gliwice, Market Square, grid sq. 36D, C. Eastern retaining wall of the staircase (s.u. 72A), east section – in the foreground; in the background, the construction of the staircase with the remains of the stairs visible (s.u. 72B). Photograph M. Michnik

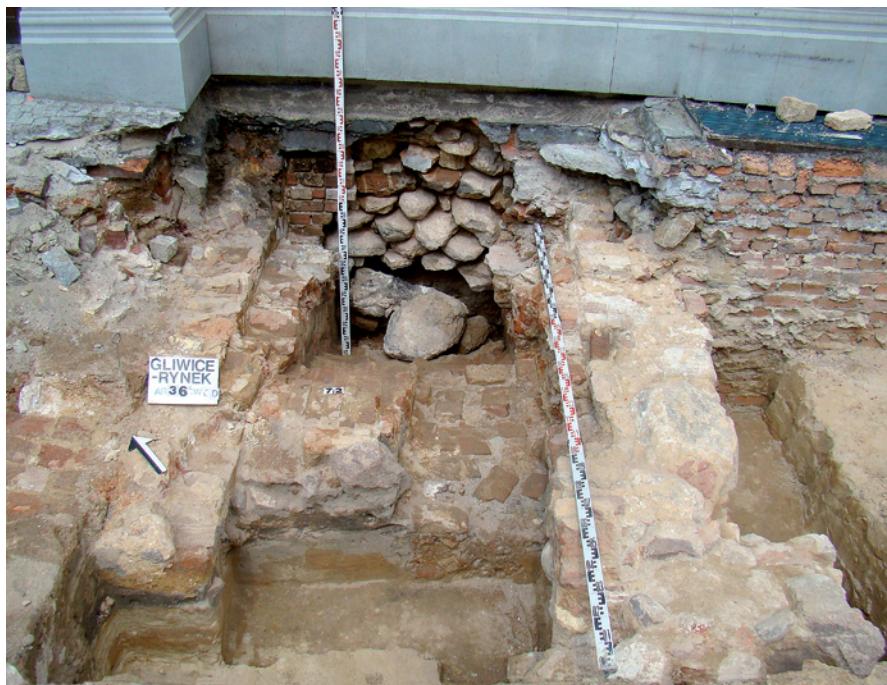
Fig. 39. Gliwice, Market Square, grid sq. 36D, C. Modern period entrances to the Town Hall cellar. Construction phase I (s.u. 72A) – blue arrow, construction phase II (s.u. 72 B) – yellow arrow. Photograph M. Michnik

The first alteration project (recorded as phase II) reduced the inside of the doorway to 1.13 m and replaced the stairway (Fig. 39). Of this new construction, five steps survive, the length of a single brick. The next project (phase IIa) focused on the entrance to the ground floor of the Town Hall building. The recorded remains indicate that in front of the Town Hall wall, to the west of the stairs to the basement,

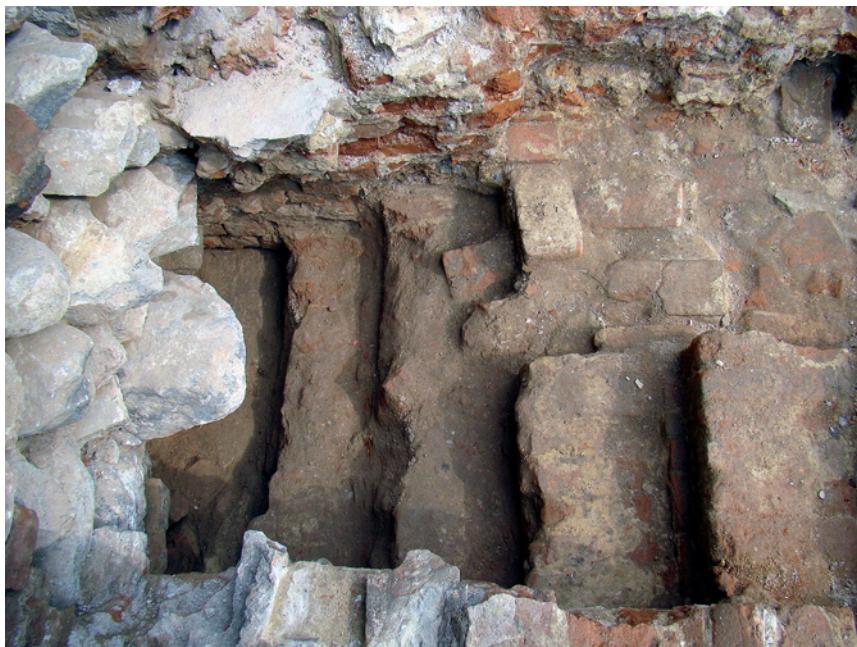
Fig. 40. Gliwice, Market Square, grid sq. 36D, C. The remains of a staircase (s.u. 72B). Photograph M. Michnik

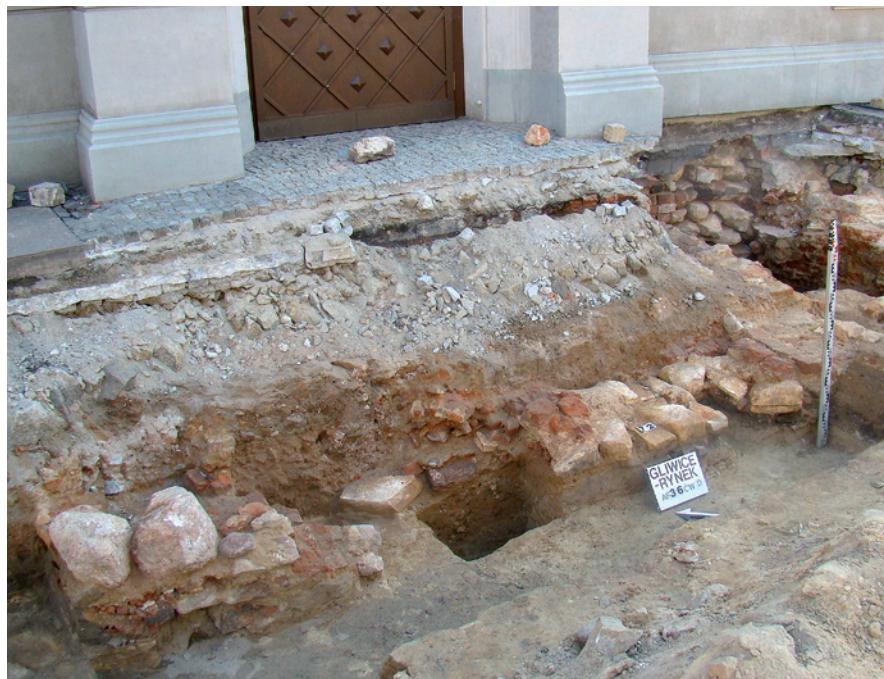
Fig. 41. Gliwice, Market Square, grid sq. 36D, C. The remains of the arcade/porch? of the Town Hall (s.u.72C). Photograph M. Michnik

directly in front of the original medieval entrance, there was a porch or an arcade leading to the doorway (Fig. 41). This structure was built of broken bricks, pebbles and limestone. The southern wall of the porch was parallel to the wall of the main Town Hall building, at a distance of 2.40 m from it.

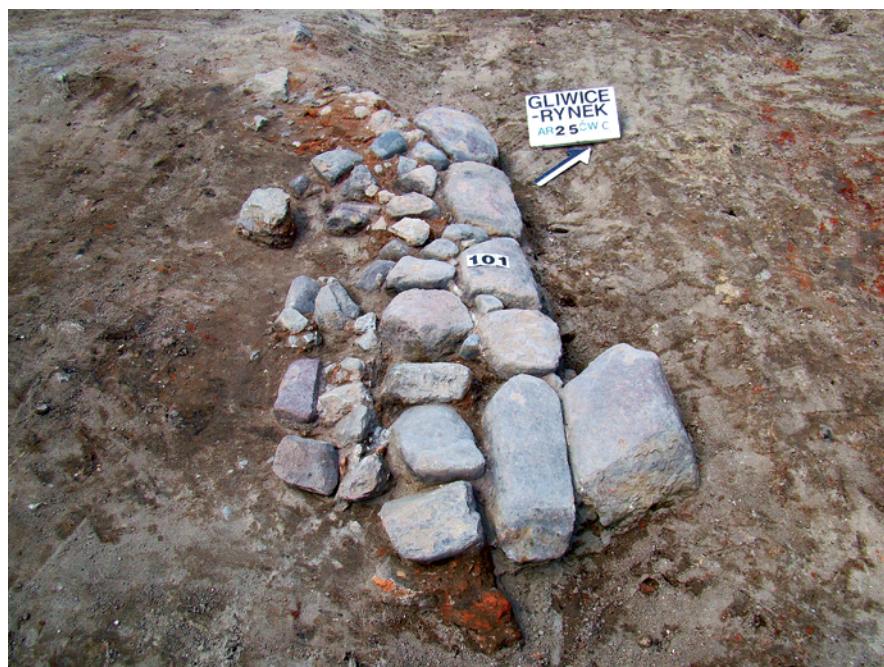
Fig. 42. Gliwice, Market Square, grid sq. 25C. The remains of a modern pavement (s.u. 101). Photograph M. Michnik

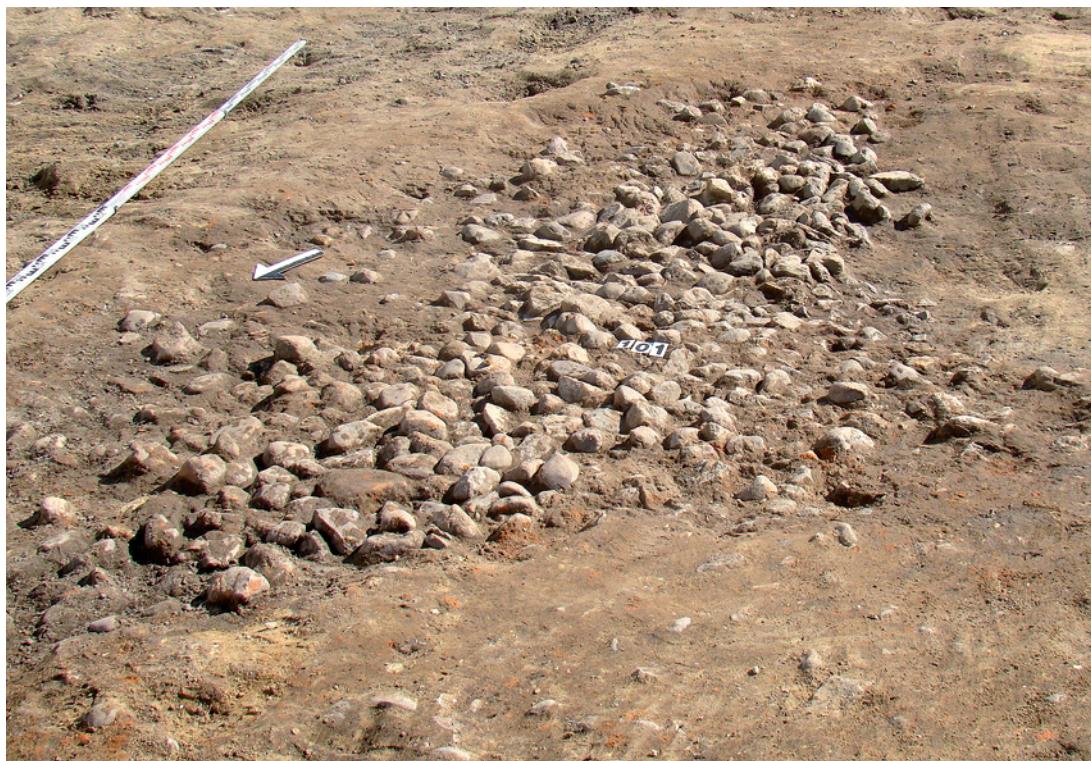
Fig. 43. Gliwice, Market Square, grid sq. 67C, D. The remains of a modern pavement (s.u. 101). Photograph M. Michnik

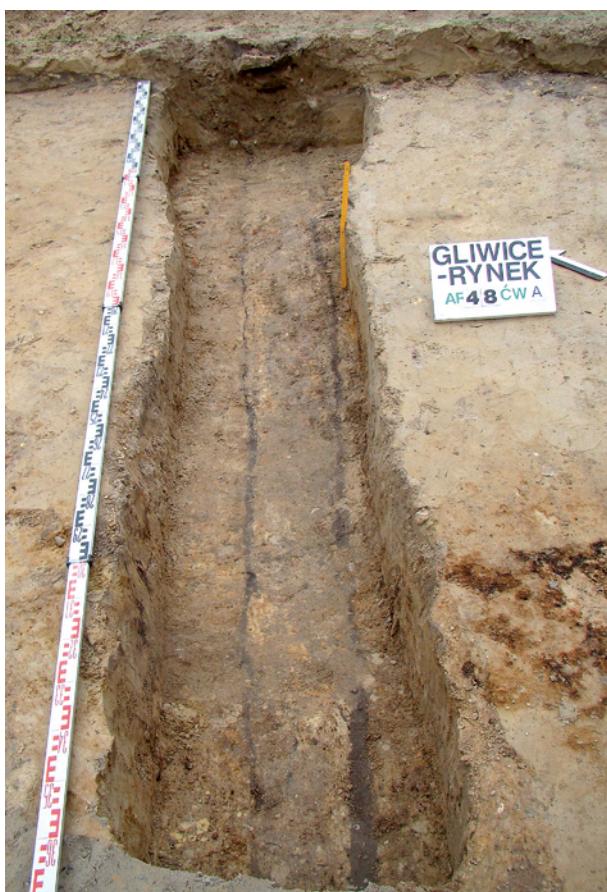
Fig. 44. Gliwice, Market Square, grid sq. 48A. Traces of a wooden water pipe (s.u. 44). Photograph M. Michnik

it forked into two branches. The second stretch (s.u. 206), discovered in the northern area of the Market Square, ran east to west. The least well-preserved lengths of piping were identified in the western area of the Market (s.u. 24A and 191). Some of them had been repaired and re-laid during a later age. The water pipes were placed in trenches at a depth of 50 – 60 cm from the upper level of the modern period layers. Locally they survived as brown stains of humus (Fig. 44) and a number of iron pipe couplings.

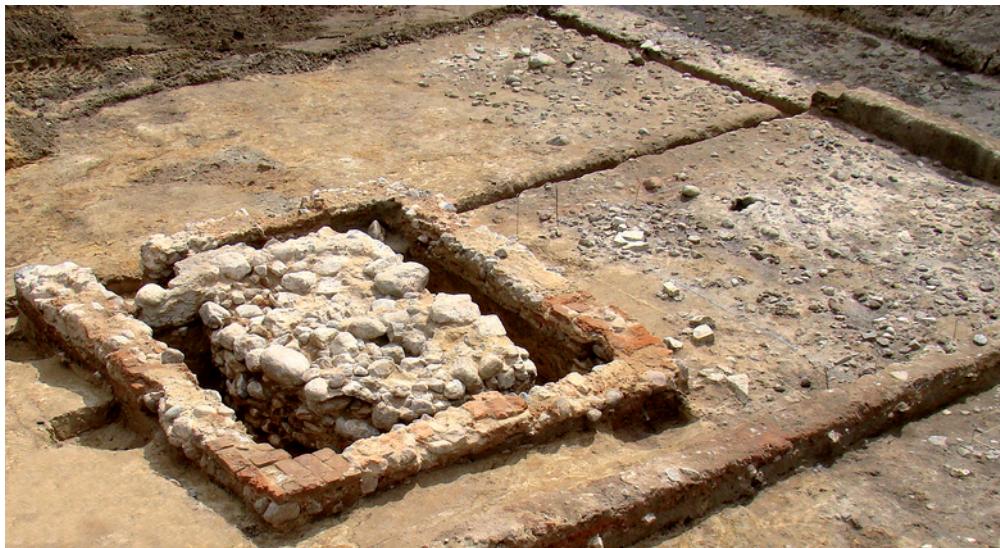
Fig. 45. Gliwice, Market Square, grid sq. 28A, B. Bottom level of the pediment for the statue of Our Lady (s.u. 28, 43 and 53). Photograph M. Michnik

Possibly the most important development attributable to phase IVa was the construction of a pedestal in the south-eastern area of the Market Square (Figs. 45, 47), as evidenced by the presence of s.u. 43, 53 and 28. This construction was in two parts. One was a solid foundation, approximately rectangular in plan (Figs. 46, 48), 2.9 m (east to west) × 1.98 m (north to south), laid of glacial pebbles, whole and broken,

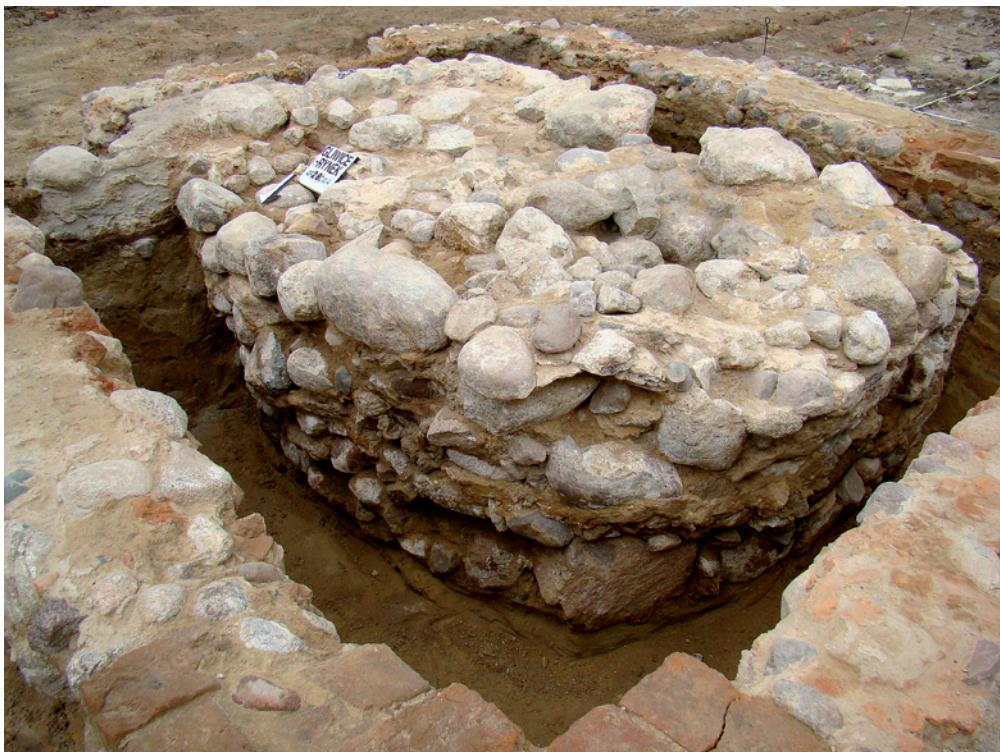
Fig. 46. Gliwice, Market Square, grid sq. 28A, B. The pediment for the statue of Our Lady in close up (s.u. 43). Photograph M. Michnik

and pieces of brick, with an average height of 9 cm. Its face is in courses of large pebbles levelled with finer material. The thickness of these layers is roughly 31 cm, which presumably corresponds to the standard of 1 foot used by the builder. The mortar was of lime, slaked directly inside the trench, and a large quantity of sand. On top of the foundation was a layer of screed made of mortar, and around it was a wall, marked as s.u. 53 and 28, rectangular in plan, its outer measurements 3.87 m × 4.55 m (east to west), extending 26 cm below the ground level as it was then. The width of this wall was determined as 44–50 cm. It was built of fine pebbles, presumably salvaged from a disused pavement, and broken bricks (Fig. 48). This material was cast into the excavation and covered over with mortar, the same as in the pediment. The role of this structure is still open interpretation. We

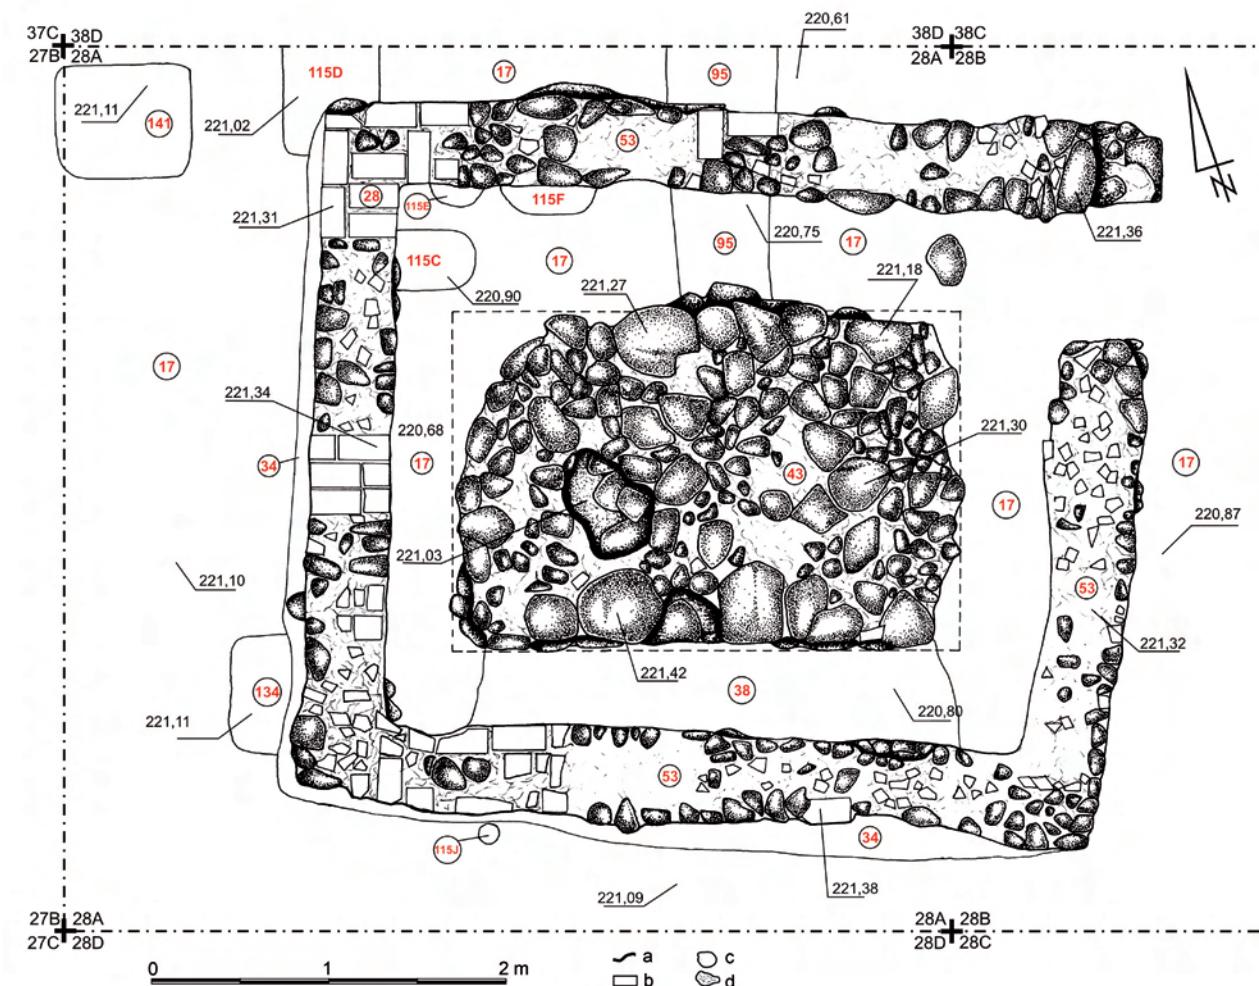
Fig. 47. Gliwice, Market Square, grid sq. 28A, B. The stone-and-brick pediment for the statue of Our Lady (s.u. 28, 43 and 53).

Plan of: s.u. 28 – brickwork; s.u. 34 – trench excavated for s.u. 28, 53; s.u. 38 – trench excavated for s.u. 43; s.u. 43 – masonry; s.u. 53 – foundation s.u. 28; s.u. 115 C-F, J – postholes; s.u. 134, 141 – modern excavation; 17 – yellow sand (natural layer); a – differences in levels, b – brick, c – stone, d – lime mortar. Drawing A. Młyński

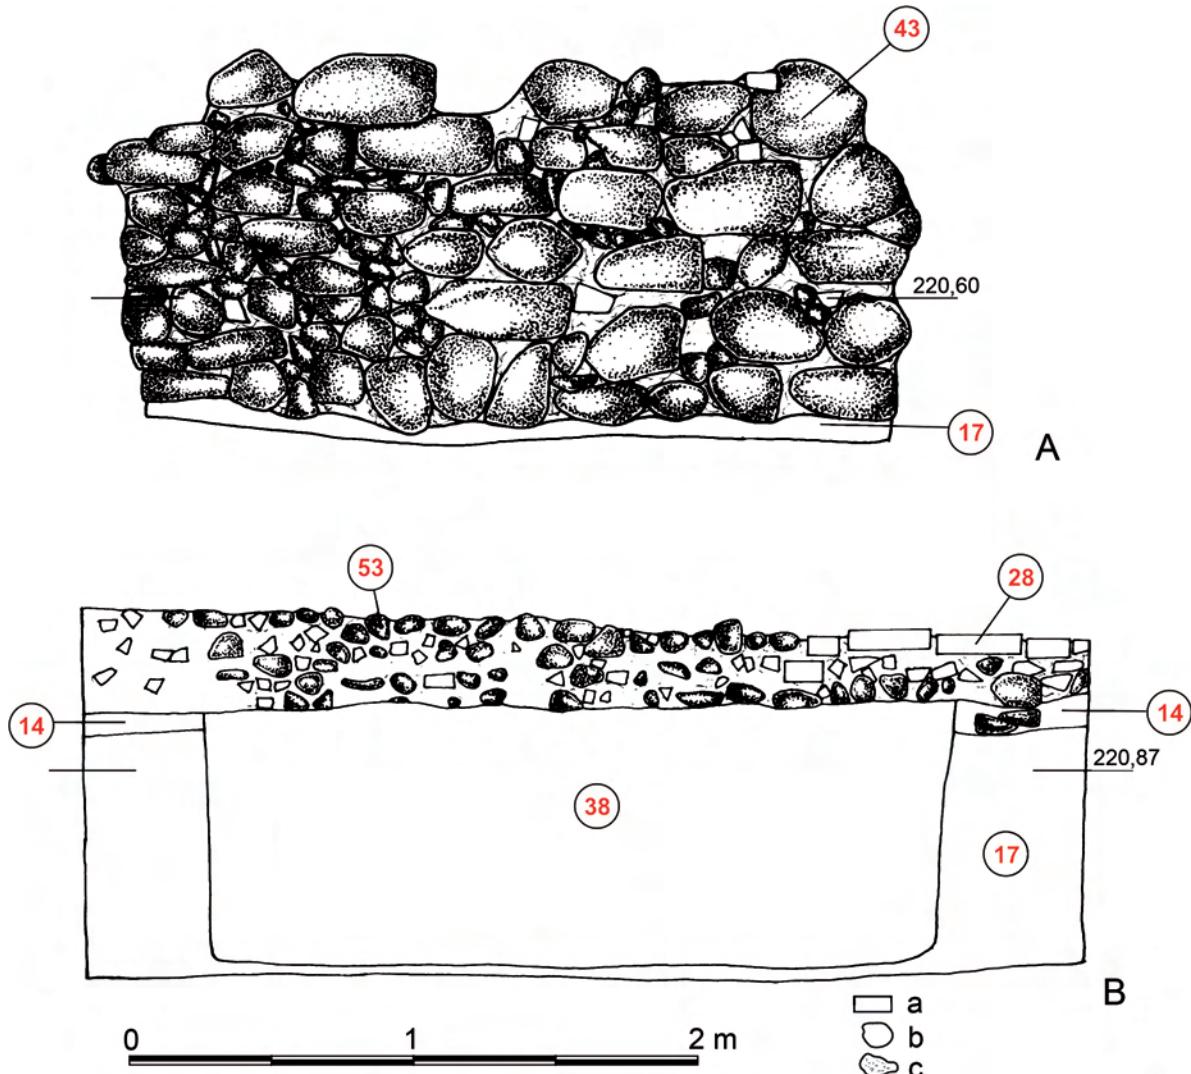
Fig. 48. Gliwice, Market Square, grid sq. 28A, B. The stone-and-brick pediment for the statue of Our Lady: A – S section s.u. 43; B – N section of south wall s.u. 28 and s.u. 53; s.u. 38 – trench excavated for s.u. 43; s.u. 14 – grey humus (13th–14th century); s.u. 17 – yellow sand (natural layer); a – brick, b – stone, c – lime mortar. Drawing A. Młyńska

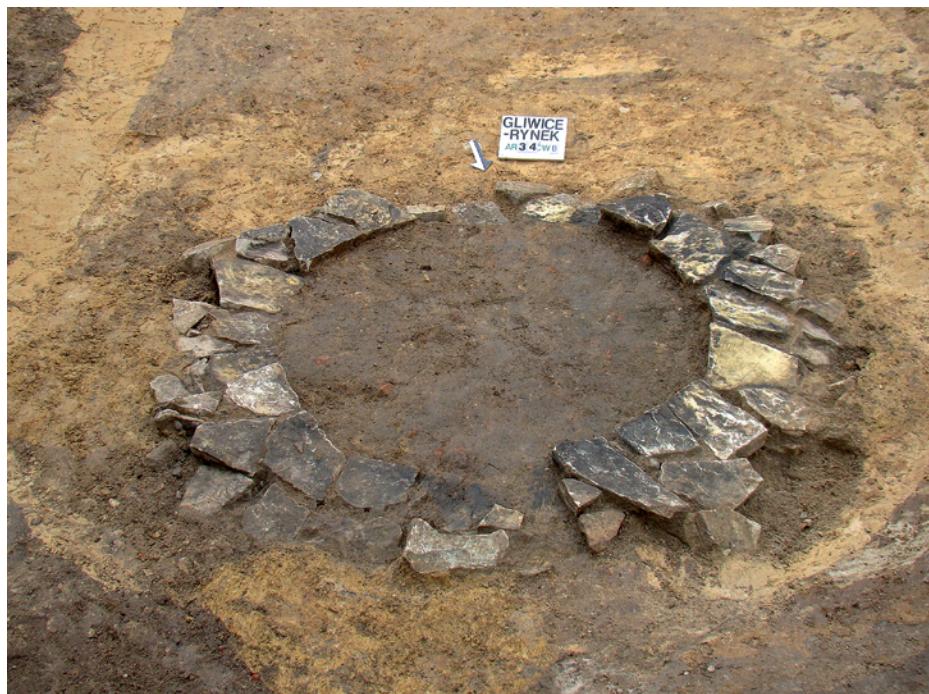
Fig. 49. Gliwice, Market Square, grid sq. 34A, B. Top layer of the modern period water well (s.u. 184). Photograph M. Michnik

At a distance of a few metres to the south of the fountain, a public water well was built (s.u. 184) (Fig. 49). It had a cylindrical casing with a diameter of 2.55 m (inner diameter of 1.58 m), of irregular flagstones laid in layers (Fig. 50). The inlet of the water pipe, which fed the well, is evidenced by an iron plate installed to block the installation after the well went out of use. The depth of this reservoir was over 2.3 m.

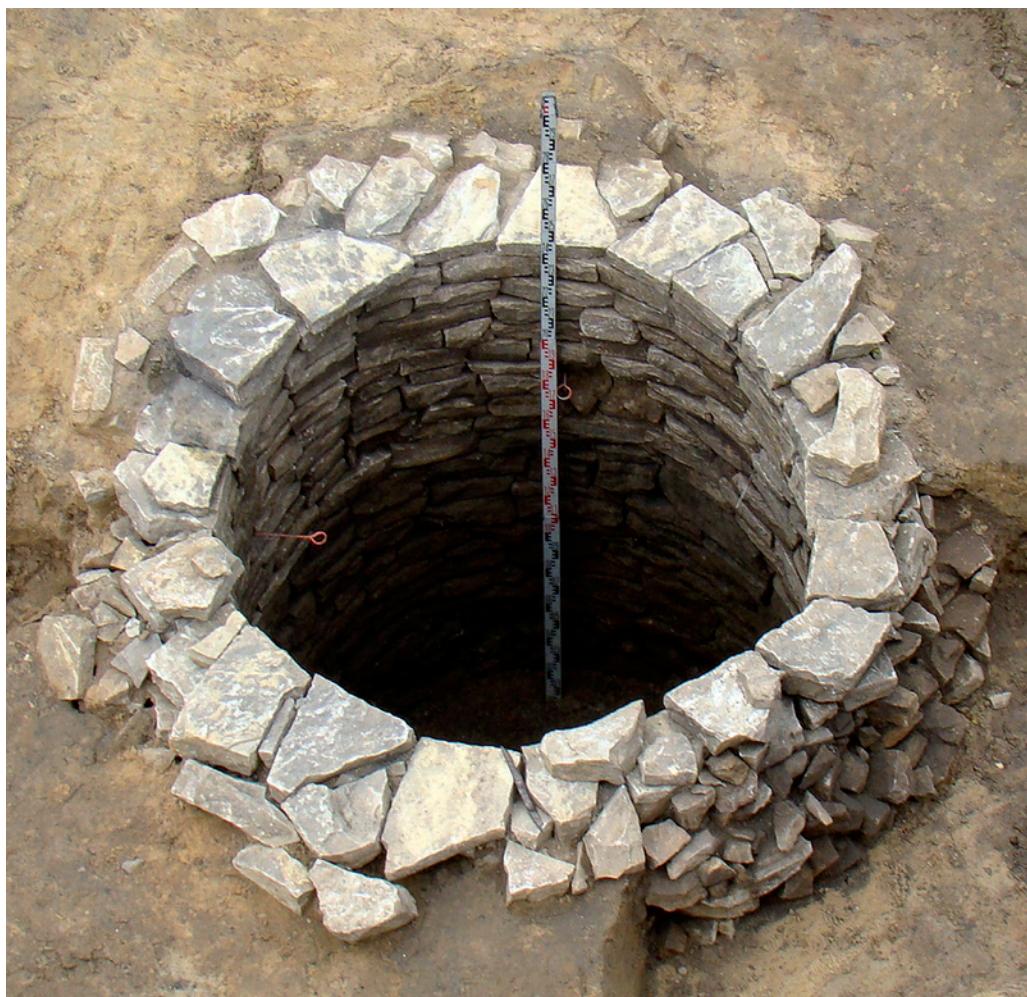
Fig. 50. Gliwice, Market Square, grid sq. 34A, B. The well during excavation (s.u. 184). Photograph M. Michnik
